*AUTHOR**G. C. POKRANDT**Project Engineer**Clutch and Coupling Engineering*

The purpose of this paper is to review and identify the types and causes of field failures of the Steelflex coupling. Solutions to prevent failures are proposed.

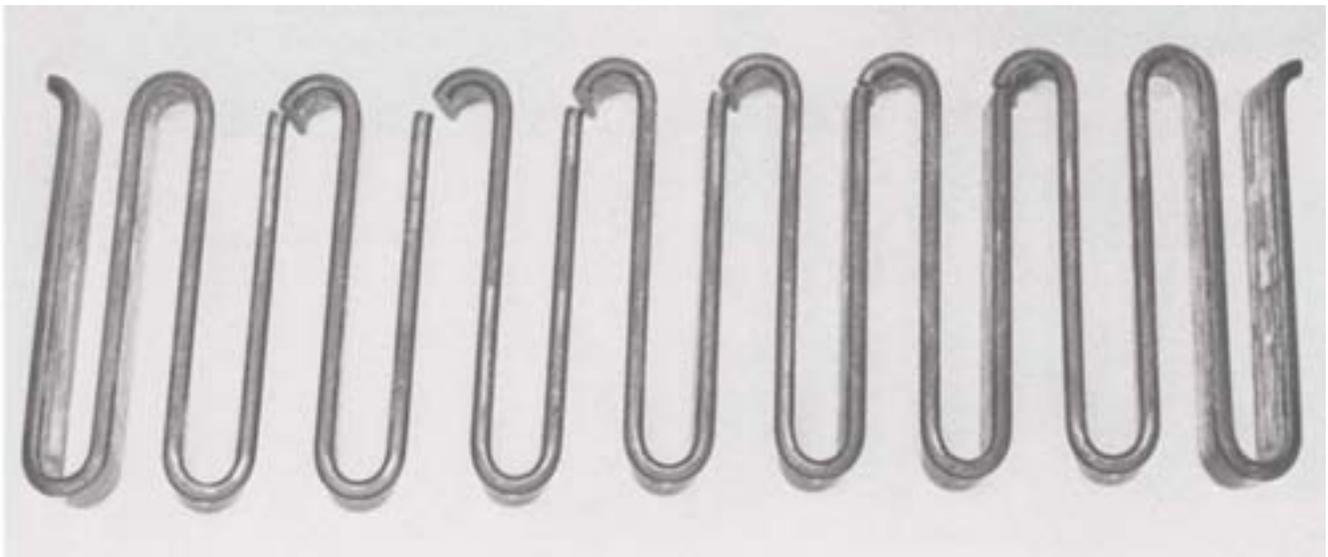
**FIGURE 1**

The location of the grid fracture on the grid rung along with pertinent operating data such as number of load cycles before failure can often be a guide to the probable failure load. Load cycles could be the frequency of a vibratory load, the number of start-ups or speed changes, or when misalignment is a load factor, it could be the number of shaft revolutions. A grid failure occurring between the tooth contact point and loop or in the loop of the grid after one million load cycles indicates a load less than 130% of grid fatigue capacity (see Figure 1).

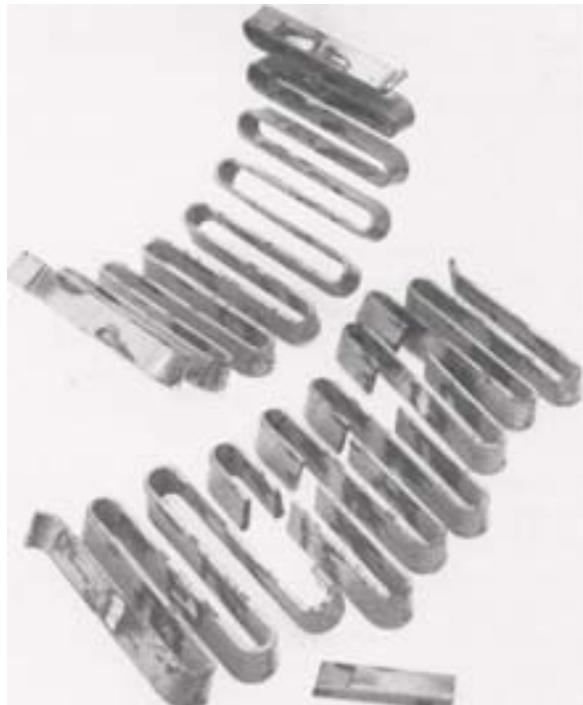
FIGURE 2 (EG-44134)

Loads higher than 130% of grid fatigue capacity are indicated when grid failure occurs between tooth contact point and the coupling hub gap before one million load contact cycles (see Figure 2).

Grid fatigue failures are a result of overloads due to torque of misalignment, or a combination of the two. Torque overloads in a system may result from starting high inertia mass, impact, and vibratory loads. Grid failures can be prevented by removing either the overload condition from the system or selecting a coupling size which has the capacity to handle the loads.

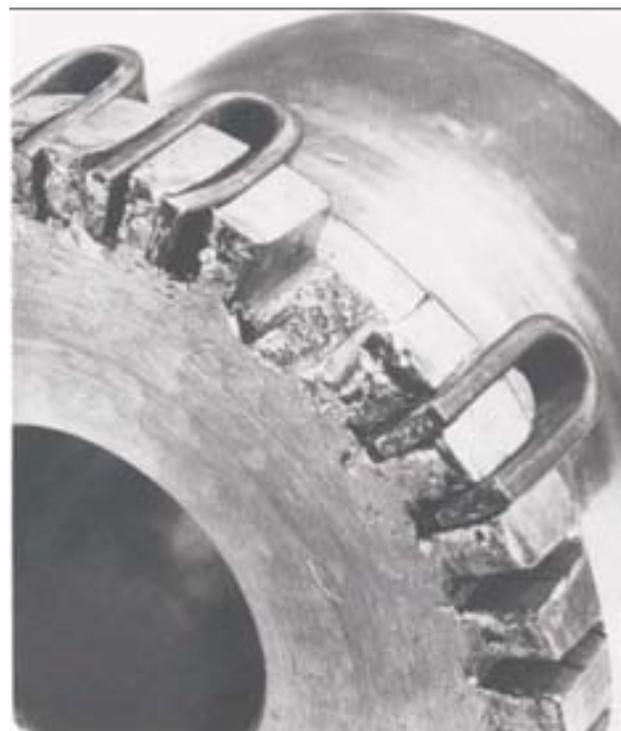
FIGURE 3 (EG-43877)

Under high peak loads (over five times the coupling rating), which could be due partially to a misaligned operating condition, the grid section may fracture in the gap portion of the coupling. This infrequent type of grid failure is often a combination of grid yield and fatigue and is usually accompanied by broken and deformed hub teeth (see Figure 3). A grid yield failure without fracture can also occur in the gap area of grid (see Figure 4).

Grid fractures and yielding in the coupling gap area can be prevented by removing system overloads and realigning shafts to eliminate excess misalignment

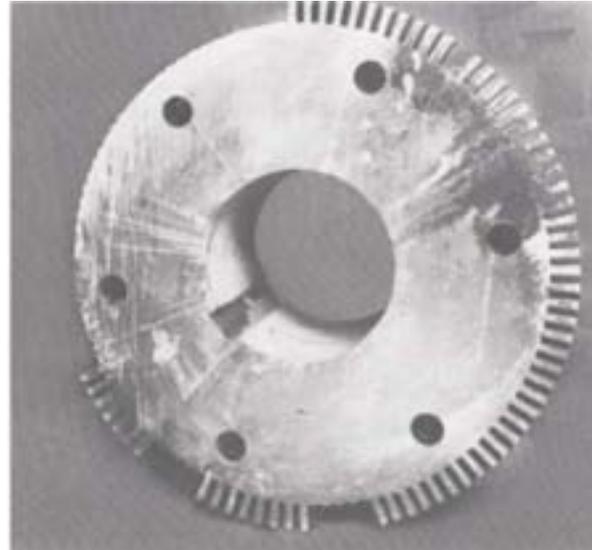
FIGURE 5

Steelflex coupling hub teeth are designed to have at least twice the fatigue strength of the grid. As a result, hub tooth fatigue failures are rare with Steelflex couplings. The yield capacity of the hub tooth is often less than that of the grid so under shock or high peak load conditions, the teeth may be permanently deformed or broken. As the result of overload and misalignment the hub teeth may break at the root diameter (see Figure 5).

Since tooth fractures will generally occur after grid failures, corrections made to the system in regard to torque load, and misalignment for grid capacity improvement will also prevent tooth fractures.

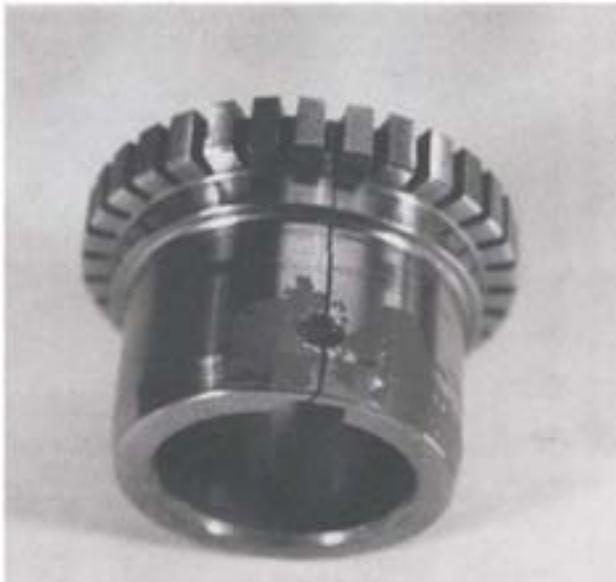
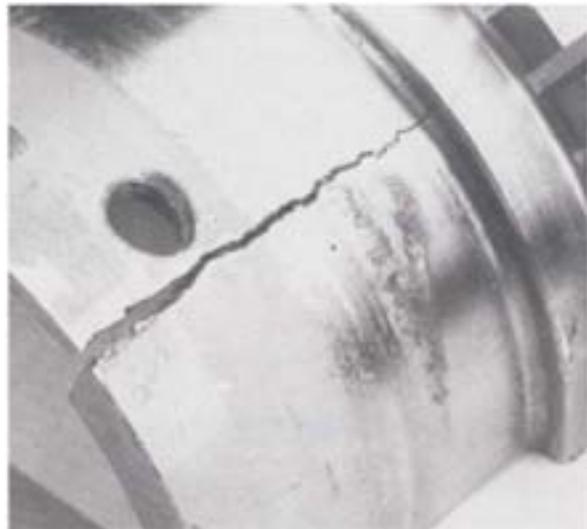
Occasionally a Steelflex coupling hub shank failure is encountered. These failures generally consist of cracks extending through the hub shank at a keyway corner or through the set screw hole. Examples of hub failures are shown in Figures 6 and 7. Steelflex hub failures can usually be traced to poor installation practices, such as hubs forced onto shaft radii, keys oversize for hub or shaft keyways, setscrews being tightened on hot hubs used for interference fits, or excessive interference fit between shaft and hub.

Hub failures can frequently be prevented by normal maintenance practices. The bore, key, and hub, and shaft keyway dimensions must be correct, setscrew tight and external parts such as bearings and supporting foundations must be in proper working order.

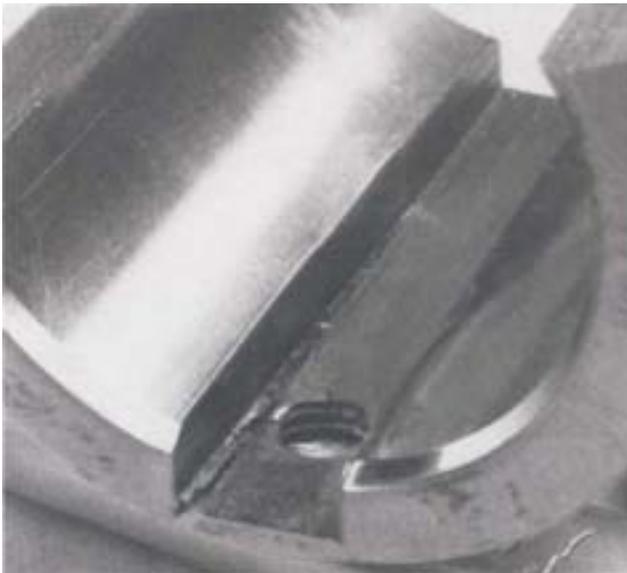
Figure 8

Sometimes a short length key is used or a key may project into the hub a short distance which may cause local yielding in the keyway (see Figure 8). The resulting loose fitted key condition may cause impact type loads on hub from system load variations and initiate hub failure. This local yielding condition is particularly critical on smaller size couplings where clearance fit hubs are preferred by most customers.

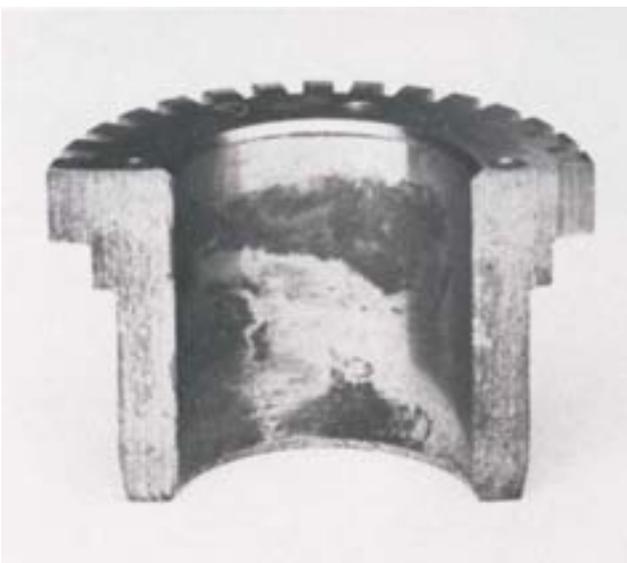
Figure 9 (EG-46154)

Another form of hub distress consists of wear and fretting corrosion in bore, Figure 9 (early stage). The cause of hub bore wear and fretting is usually radial clearance or light interference fit between hub bore and shaft which permits axial or planetary motion of hub on the shaft. Clearance fit hubs having loose setscrews may permit sliding or rocking of hubs, frequently with each shaft

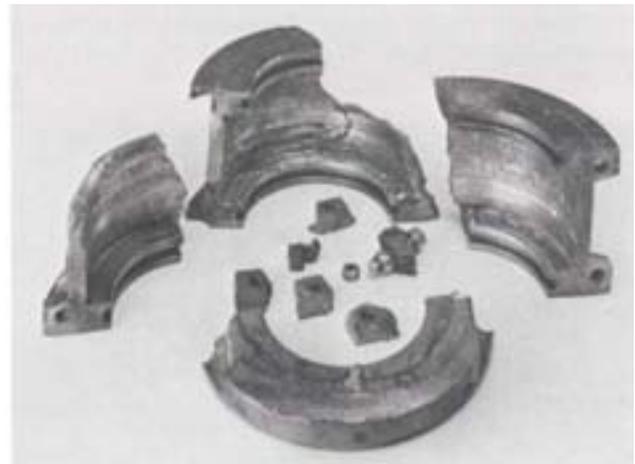
Figure 10 (EG-43878)

On rare occasions, covers have broken apart, Figure 10. In this case, the coupling was subjected to repeated high loads that caused grid failures of every rung near the gap. This permitted the driving hub to turn independent of driven hub. The cover spun with driving hub until grid pieces became wedged between the stationary hub and rotating cover, resulting in destruction of one cover half. The coupling size was obviously improper for the particular system loadings.

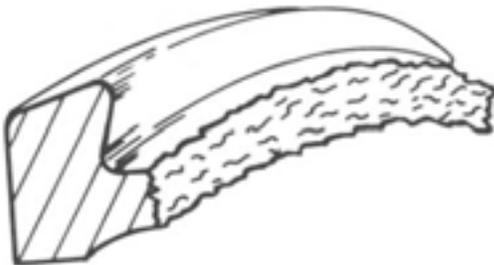
FIGURE 12

The grease lubricated Steelflex coupling uses contact type seals between the cover and the hub shank outside diameter. The T20 steel stamped cover uses a seal that fits over the inside diameter of the cover seal flange. If the hub shank outer surface is dry, rusted, or scratched, this seal may roll over in assembly of the cover, Figure 11, and cause the seal to come off the cover flange or become cut from the cover flange, Figure 12. The seal may also be cut due to excessive misalignment. To minimize seal roll over, lightly lubricate the hub shank to permit the seal to slide freely until the half cover is assembled in place.

Section of  
Failed  
T20 Seal

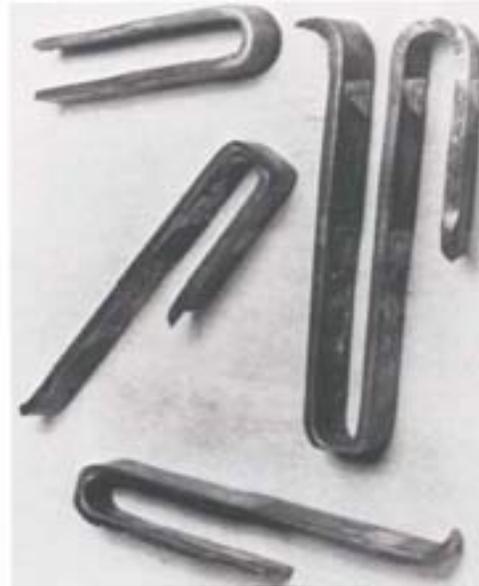
Figure 14

With inadequate lubrication, wear will occur on the grid surfaces that are subjected to a sliding action. This wear occurs when there is reciprocating motion occurring between contacting surfaces, localized loading, and lubrication deficiency. In the early stages of lubrication deficiency, the contact area appears scuffed. If the coupling continues operating with a lubrication deficiency, worn grid surfaces will result. Sometimes fretting corrosion, as evidenced by the appearance of a red powder, can be noted. With continued grid wear, grid breakage will finally result when grid section is sufficiently reduced, (see Figure 14).

In general, excessive grid wear conditions can be minimized with adequate lubrication and correct alignment. Where vibratory type loads are expected, proper service factors should be used in coupling size selection to minimize the load effect on the grid.

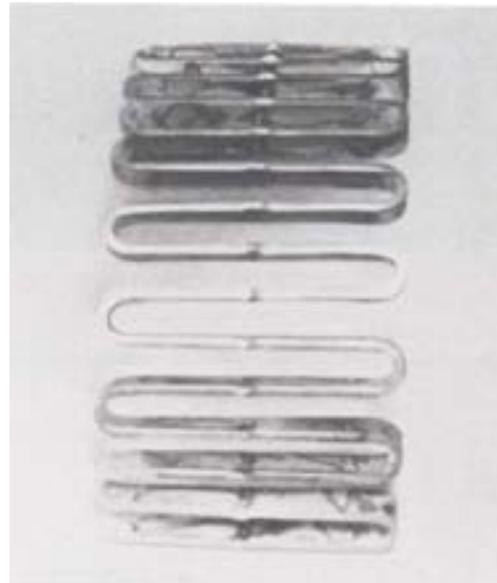
Figure 15

Combinations of torque load, misalignment, and rotational velocity produce forces that result in grid loop end and radial outer grid edge wear. Measurable grid end wear is an indication of frequent vibratory pulsations. A combination of grid end wear and wear on radially outer edge of grid where it strikes the inside of cover are indications of excess shaft misalignment (see Figure 15). Rotational speed affects the severity and frequency of occurrence of grid wear.

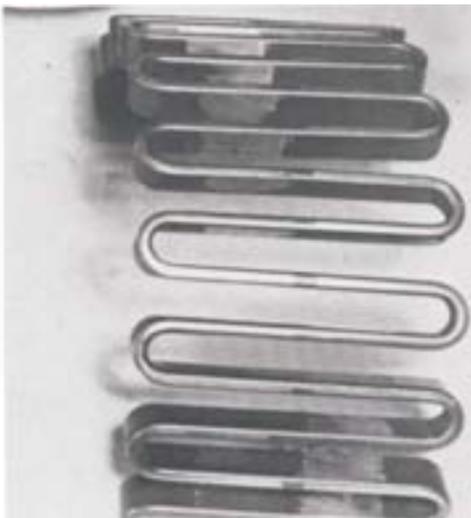
Figure 13

Installation and operating characteristics of the coupling can often be determined from the grid contact pattern. Such factors as gap setting, reversing load, axial movement, or parallel misalignment can be noted. Grid contact near the gap end of tooth denotes high torque loads. An example of normal grid contact patterns is shown in Figure 13.

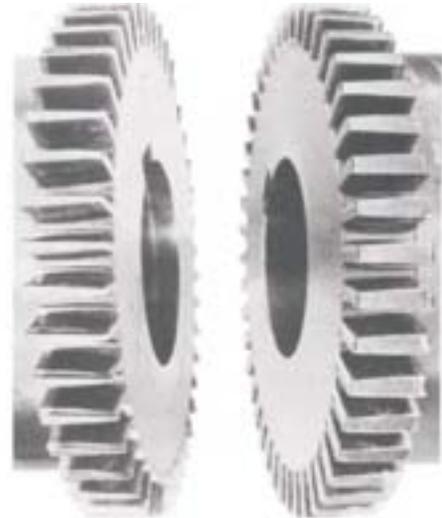
Figure 16 (EG-41776)

Hub teeth also become worn from lack of lubrication and the sliding of the grid from load variation, misalignment or axial shaft movements (see Figure 16).

Since tooth fractures and wear failures of hub teeth will generally occur after grid failures, corrections made to the system in regard to torque load, misalignment and lubrication for grid capacity improvement will also prevent the hub tooth-failure problems.

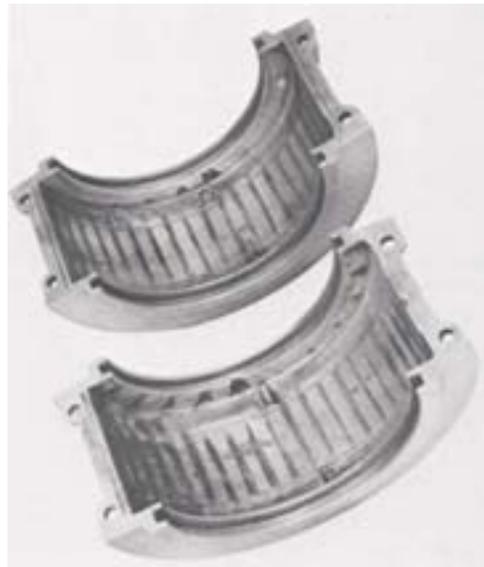
Figure 17 (EG-41646)

Since the cover must retain the grid both axially and radially, it is normal to find markings or shallow grooves in the inside cover diameter. Deep grooves, Figure 17, indicate coupling is operating under parallel misalignment exceeding operating recommendations. Since the cover is not a load carrying component of the coupling, such markings on the cover inside diameter will not affect the torque load transmitting ability of the coupling.

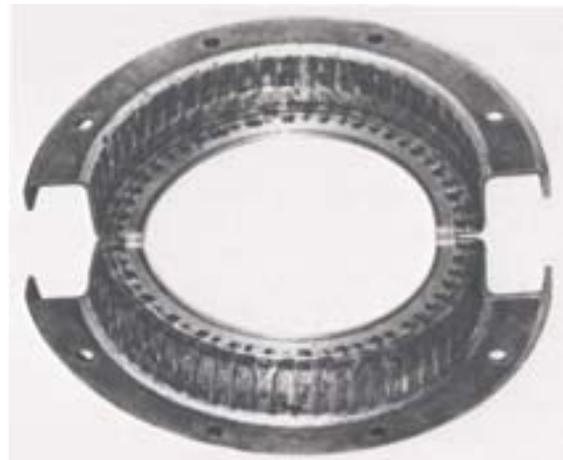
Figure 18 (G-6187)

The end flange of the covers may have indentations from the grid ends. These markings are also a normal result of coupling operation and are of concern only if their depth approaches one-half of the side wall thickness, Figure 18. Deep indents are an indication of high vibratory loads or high starting torque loads. Operating under excess misalignment will also produce deep cover indentations from the grid ends.
