## Introduction

The purpose of this paper is to review the areas in which gear couplings have experienced difficulties and to identify the various types and probable causes of failures.

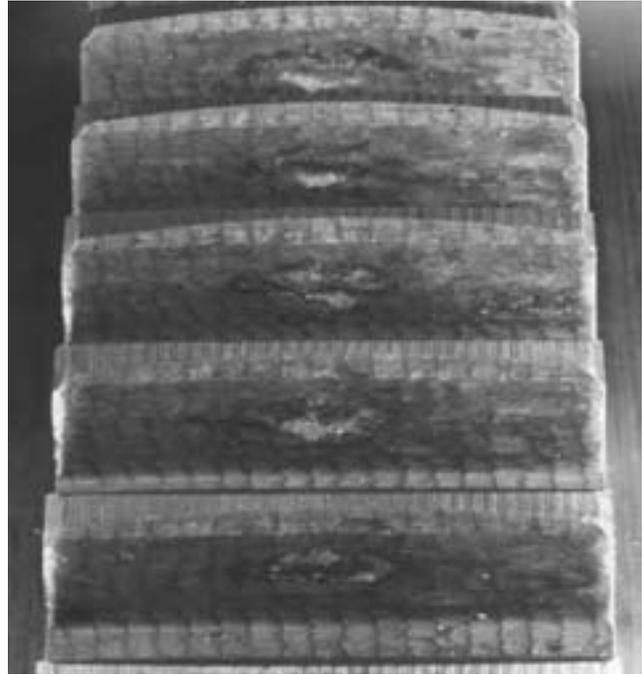
Figure 1

The greatest problem in successful operation of gear couplings is to maintain an adequate film of lubricant between the gear teeth. It has been found that a lack of proper lubricant is the principal cause of gear coupling failures. Early stages of lubrication deficiency are shown in Figure 1. The contact area appears scuffed. As a result of the loss of lubricant film between the external and internal teeth, the surfaces rubbed against each other causing small metal particles to break loose. In some cases fretting corrosion, as evidenced by the appearance of a red powder, may be noted. The contacting internal sleeve tooth has a similar scuffed contact area as illustrated in Figure 2.

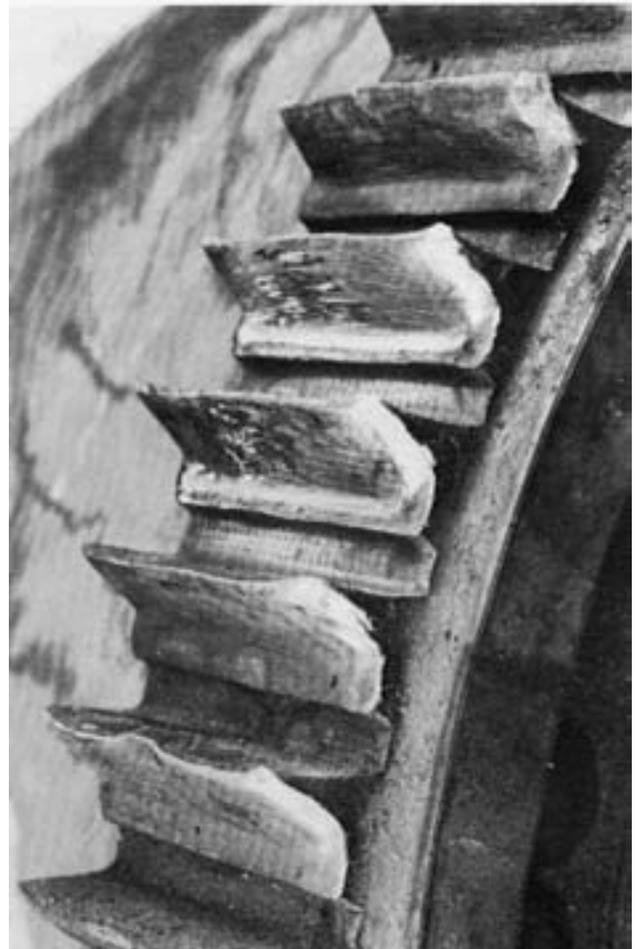
Figure 3

Continued operation of a gear coupling with a lubrication deficiency often produces a badly worn surface, as shown in Figure 3, where 70% of the tooth is worn away. Ultimately, unless the wear can be stopped, the tooth will bend over, as shown in Figure 4, and the mesh will become disengaged. The sleeve or internal teeth may suffer similar wear damage, see Figures 5 and 6, although generally the hub or external teeth will bend or roll over before the sleeve teeth. Proper coupling operation requires both sufficient and correct lubrication.

The lack of lubricant in gear couplings is usually the result of an insufficient lube filling, an omitted lube plug, or a damaged seal or gasket. If oil is used as the lubricant, leakage often occurs through the shaft keyway, unless the keyways are adequately sealed.

Other reasons for lubricant deficiencies in gear couplings may involve the lubricant itself. The lubricant, either grease or oil, may have improper viscosity for the operating speed or temperatures. In the case of grease lubricants, the oil may separate from the soap base because of centrifuging. In all these cases the lubricant either becomes too thin to support the tooth mesh load or is too thick to flow into the tooth mesh contact area. For these reasons an extreme pressure (EP) lubricant of the correct type, as well as speed and temperature limitations must be adhered to. Refer to Manual 458-010.

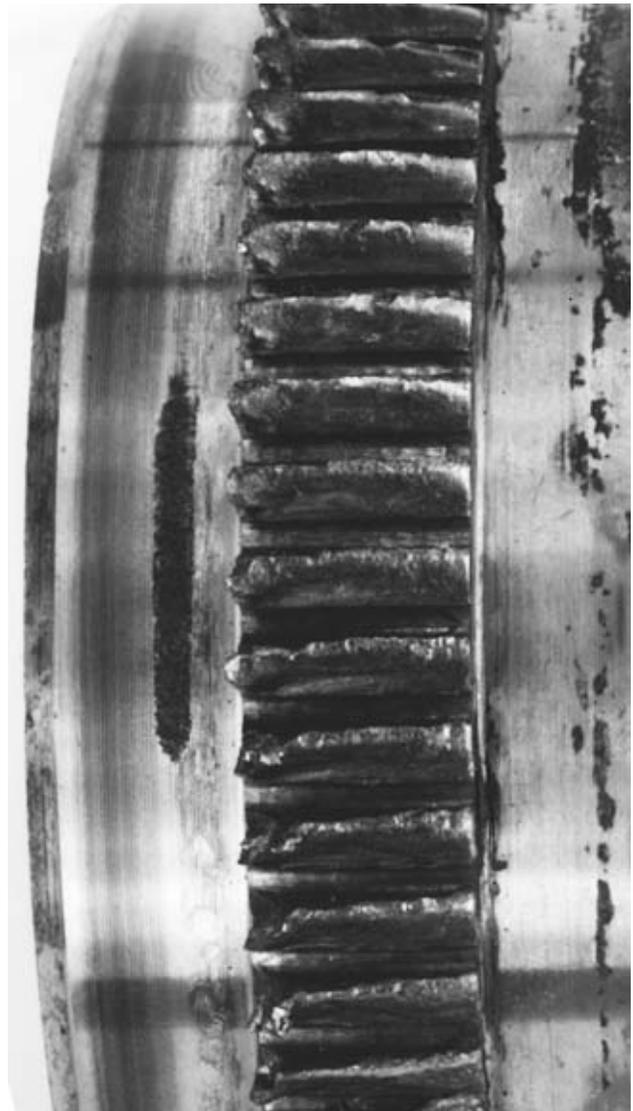
Figure 7

Operating a gear coupling under excessive misalignment will promote wear on the teeth. The gear coupling is designed so that it will accommodate the alignment limits given in the service manual without metal to metal contact in the seal area. If wear is noted in the hub seal area as in Figure 7, it is proof that this coupling was operated with excessive misalignment. The illustrated tooth wear could be attributed to a combination of tooth sliding movement and lack of lubricant because the probability of lube leakage at the seal increases with misalignment.

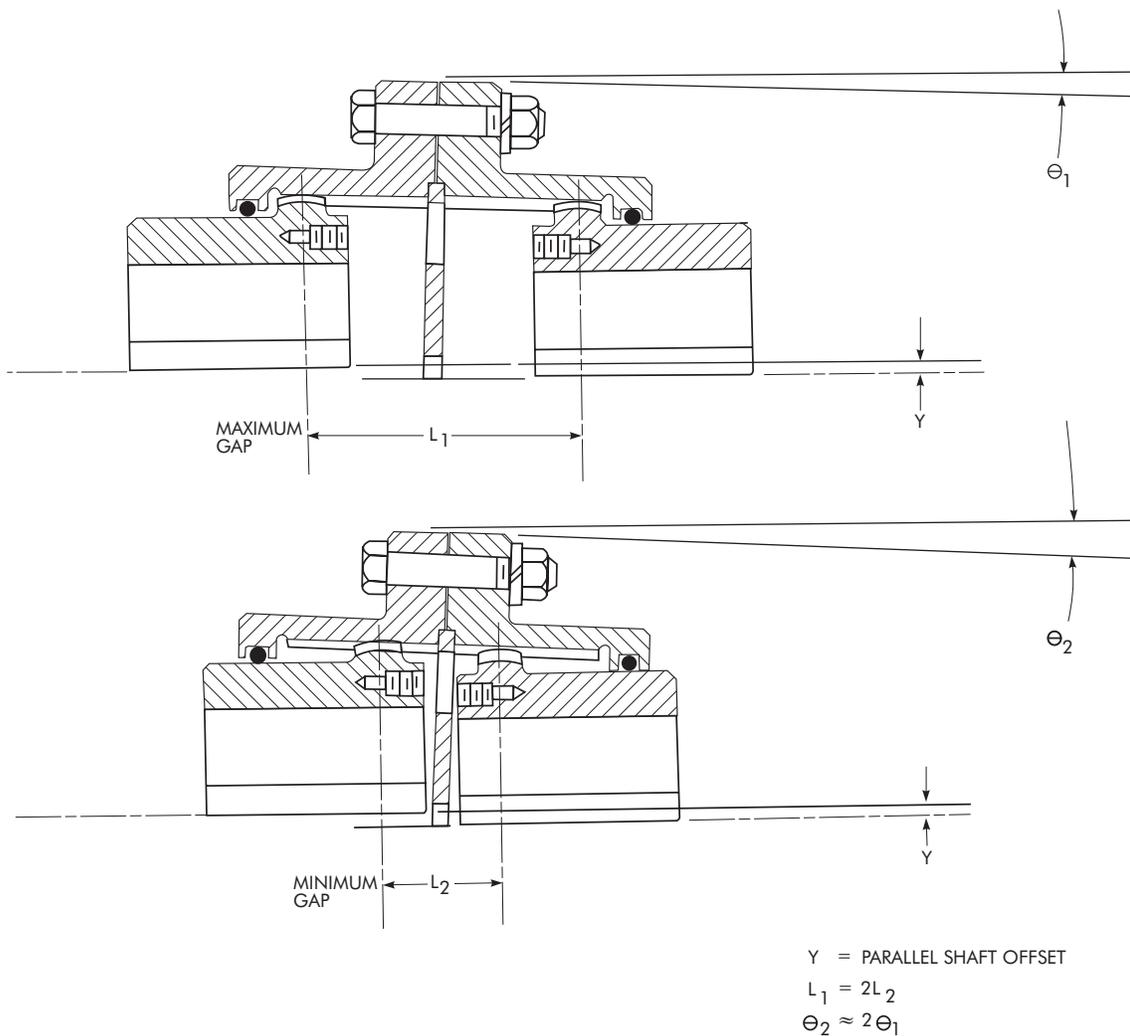
Figure 8

If a Slide type gear coupling operates so that its hub teeth mesh with the sleeve teeth near the gap, as shown in Figure 8, the static misalignment capacity of the coupling will be reduced to a maximum of 1/2° per mesh. For example, reducing the distance between tooth mesh areas by one half will nearly double the sleeve tilt angle. With increased tilt there will be increased sliding between the mating teeth and a greater possibility of scuffing. For this reason, installations of slide type gear couplings require close attention to alignment and speed limits.

If axial hub movement occurs more than 5 times per hour, add 0.25 to the normal service factor as noted in the selection procedure of Selection Guide 451-110.

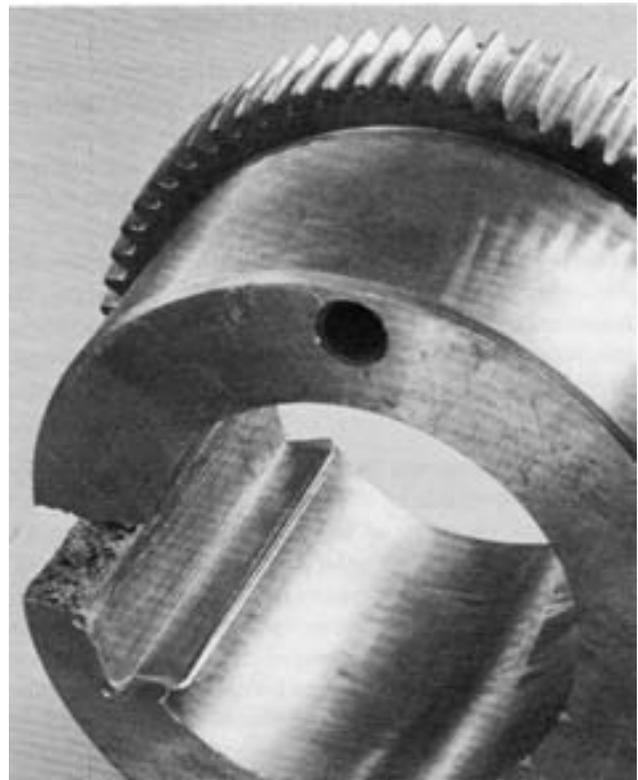
Figure 10

An example of a hub failure from a single overload application is shown in Figure 9. The break in the hub occurred at one corner of the keyway and extended the full length of the hub. Another view of the same hub, Figure 10, shows a deformation of the keyway from the key. It can be noted that the hub break occurred at the keyway corner away from where the load was applied.

In order to prevent hub fractures, it is necessary that couplings be selected using the proper service factor for the application based on motor capacity or where a brake is involved in the system, the coupling should be selected on the brake capacity.

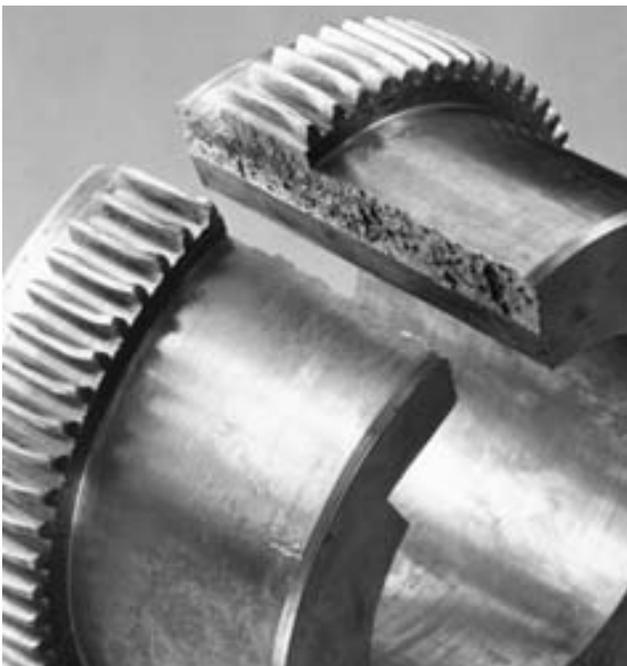
Figure 9

It is possible to have gear coupling hubs fail over the keyway from a combination of hoop stress produced by the interference fit and a high tensile stress as a result of excessive torque loads transmitted through the key. Gear coupling hubs are normally made from a .3 to .5 carbon steel having a minimum tensile strength of 65,000 psi.

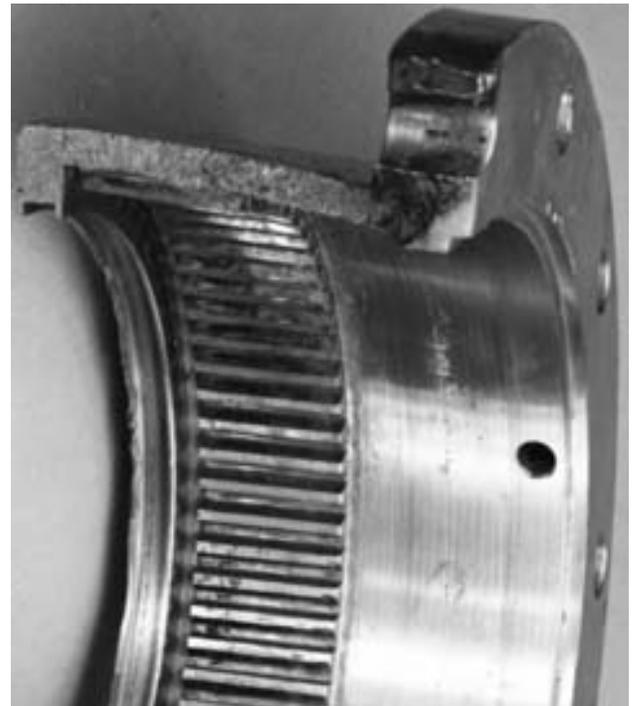
Figure 11

As a result of the hub failure shown in Figures 9 and 10, the mating sleeve had a crack extending nearly its full length, Figure 11. In order to remove the sleeve from the hub, it was necessary to cut the sleeve in the section at the failure crack and 180° away from the crack. It is interesting to note that none of the teeth in either hub or sleeve were broken.

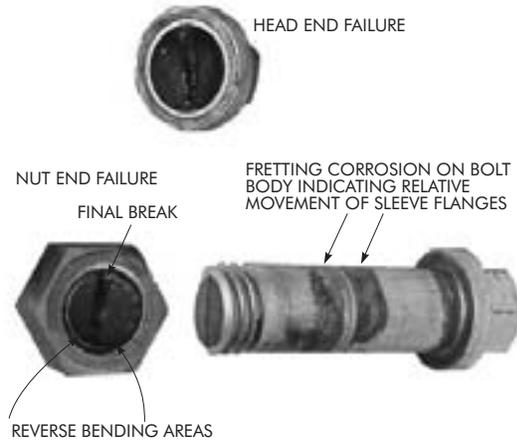
Figure 12

In most applications the combination of the frictional transmitting torque of the bolted flanges plus the allowable shear capacity of the bolt body are sufficient to transmit the normal starting and operating loads applied to a properly selected gear coupling. In certain cases, where high starting and impact loads occur in combination with reversing service or severe load fluctuations exist, fasteners have failed in reverse bending fatigue, as shown in Figure 12. This failure shows that the bolt head actually “fatigued off” of the bolt body diameter. It should be noted that the characteristic “beach marks”, that often form on the fracture surface of soft material, are not always exhibited to the naked eye in high strength material failures. For this reason the mode of failure, ie; bending fatigue, may not be properly identified.

Bending fatigue loading may also be characterized by: fretting corrosion on the bolt body diameter, imbedding of the bolt washer face diameter into the sleeve, wallowing out of the sleeve flange holes and/or offset of the bolt body diameter.

This type of failure can be the result of insufficient fastener tightening torque, system torsional vibration or reversing loads which exceed the flange joint capacity.

Assuming that the flange fasteners have been installed with the proper tightening torque as specified in the installation manuals, fatigue type fastener failures of a gear coupling are an indication of loads that repeatedly exceed 1.5 to 2.5 times rated torque of the coupling.

One must use care when correcting flange bolt failures. Before substituting higher hardness fasteners or a larger coupling size which would reduce the possibility of further coupling failures, review the loads in the entire system to be sure that other

elements will not fail. In some cases, a simple correction of bolt failures has led to extensive damage to other critical connected machinery. In most cases, if the coupling was properly selected for the drive, flange bolt failures would be an indication that the system has been subjected to unexpected overloads.

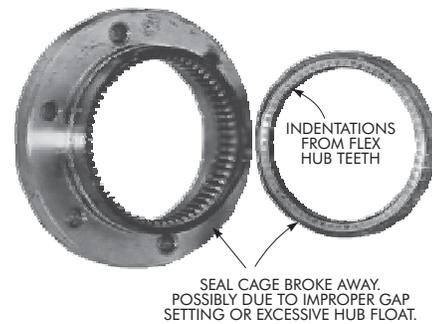
Figure 13

Sleeve seal end ring fatigue failures, Figure 13, result from loads imposed on the sleeve seal cage. This type of failure may be the result of radial flexing under excessive misalignment, and/or axial contact due to improper gap setting (too large), or hub axial float. Refer to Manual 428-870, “Axial Movement of Power Transmitting Shaft Coupling”. Also note the hub tooth contact pattern on the seal cage face, Figure 13.
