FAILURE ANALYSIS GEARS-SHAFTS-BEARINGS-SEALS

CONTENTS

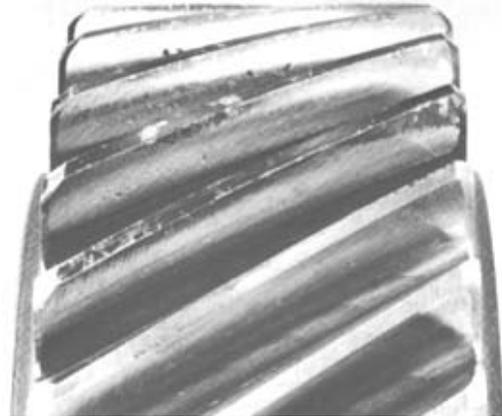
INITIAL PITTING is caused by local areas of high stress due to uneven surfaces on the gear tooth. This type pitting can develop within a relatively short time, reach a maximum and with continued service polish to a lesser severity. Initial pitting shown in **Figure 2.3** usually occurs in a narrow band at the pitchline or just slightly below the pitchline. It is most prominent with through-hardened gears and is sometimes seen with surface-hardened gears.

FIG. 2.3 (683-2) INITIAL (CORRECTIVE) PITTING

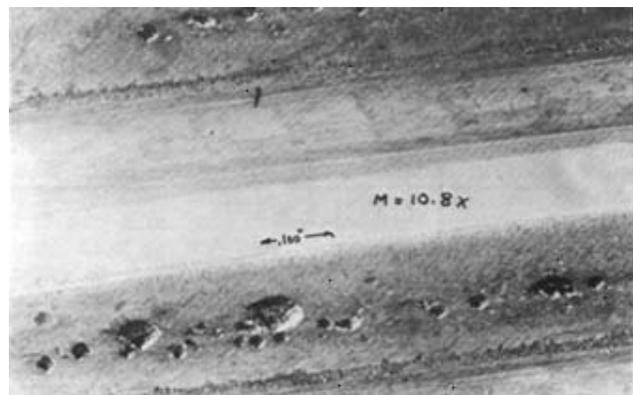
The shape of a classical pit is shown in **Figure 2.4**. It appears as an arrowhead pointing in the direction of on coming contact. Starting at the surface of the tip of the arrowhead, the fracture proceeded inward at a shallow angle to the surface. Simultaneously, the crack broadened forming the arrowhead. The back side of the pit has a steep side. The magnified pit shown in **Figure 2.4** is shown with the remaining portions of the tooth in **Figure 2.5**. Although there were several large pits on the tooth surface, this pitting was corrective since it progressed no further with continued operation.

FIG. 2.4 (683-9) INITIAL (CORRECTIVE) PITTING ENLARGED PHOTO

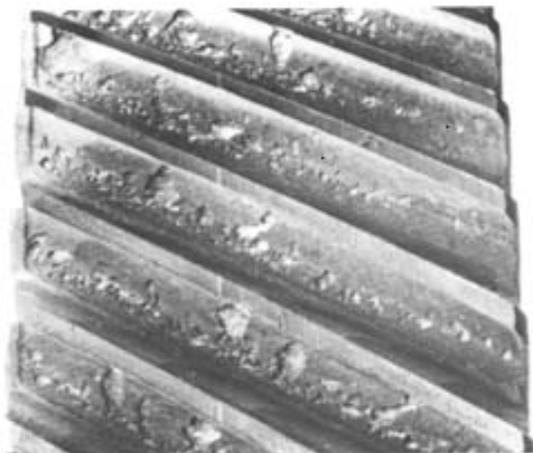
DESTRUCTIVE OR PROGRESSIVE PITTING on the other hand usually starts below the pitch line, in the dedendum portion of the tooth and progressively increases in both the size and number of pits until the surface is destroyed. Destructive pitting can appear to be as severe as corrective pitting at the beginning of operation, however, as time goes on the severity of destructive pitting sharply increases and far surpasses the severity of corrective pitting as shown in **Figure 2.6**. **Figure 2.7** illustrates this type pitting on a through-hardened gear. **Figure 2.8** shows destructive pitting of a surface hardened gear.

FIG. 2.7 (828-1) DESTRUCTIVE (PROGRESSIVE) PITTING THRU HARDENED GEARS

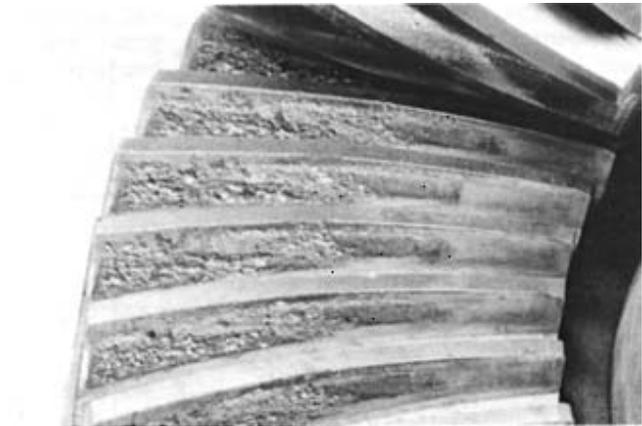
FIG. 2.8 (2342-2C) DESTRUCTIVE (PROGRESSIVE) PITTING

Destructive pitting usually results from surface overload conditions that are not alleviated by initial pitting. If tooth surface hardness is within specified values, system overloads are usually the cause of such pitting. To see a finely pitted gear, with several large pits is no cause for alarm since it can be of a corrective nature, see **Figure 2.9**.

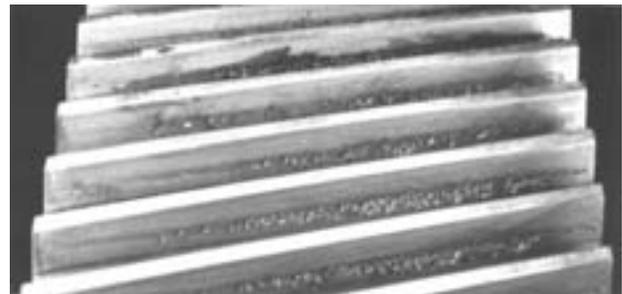
FIG. 2.10 (2342-4C) NORMAL DEDENDUM WEAR

NORMAL DEDENDUM PITTING (DEDENDUM WEAR) of fully loaded through-hardened gears manifests itself as small or modest size pits, covering the entire dedendum portion of the tooth flanks. Continued operation results in pit rims being worn away with virtually no further pitting occurring. **Figure 2.10** shows the tooth appearance in the pitting phase, prior to pit rim wear. **Figure 2.11** illustrates a dedendum pitted gear tooth after pit rims have been worn away.

Dedendum pitting results when loads are at or close to maximum allowable surface loading values. The dedendums are most vulnerable to this phenomenon because of the preferential orientation of the surface microcracks along the tooth profile. **Figure 2.12** illustrates this. The orientation of the cracks in the dedendum of both pinion and gear are such that oil is

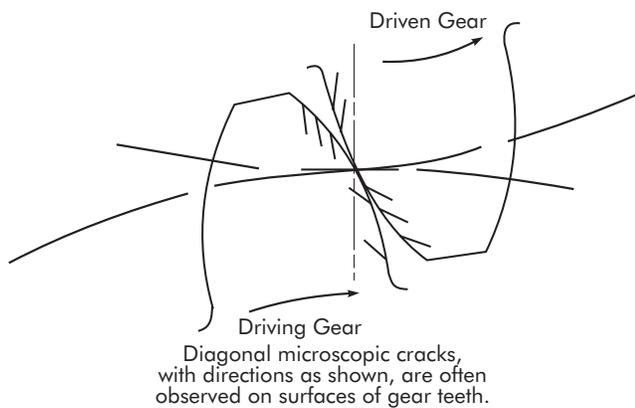
FIG. 2.12 (2342-5C) TOOTH SURFACE MICROCRACKS

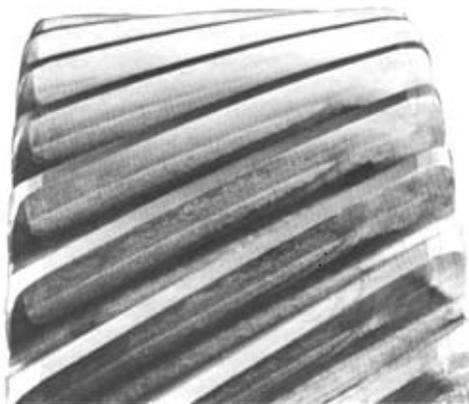
FIG. 2.13 (683-12) MICRO-PITTING (FROSTING)

MICRO-PITTING (FROSTING). **Figure 2.13** shows a micro-pitted carburized tooth as it appears to the naked eye and **Figure 2.14** shows the surface and micro-pitting enlarged 430 times. This type of pitting is considered to be normal.

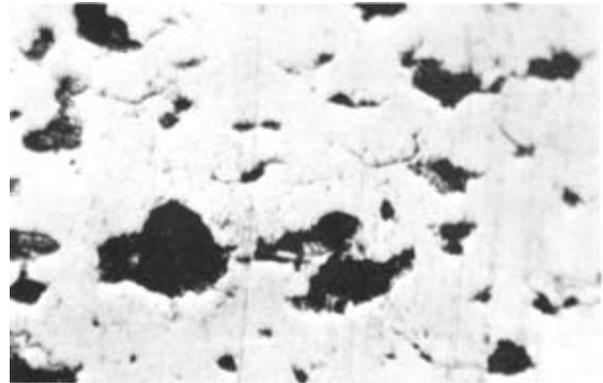
FIG. 2.14 (2342-6C) MICRO-PITTING (ENLARGED PHOTO)

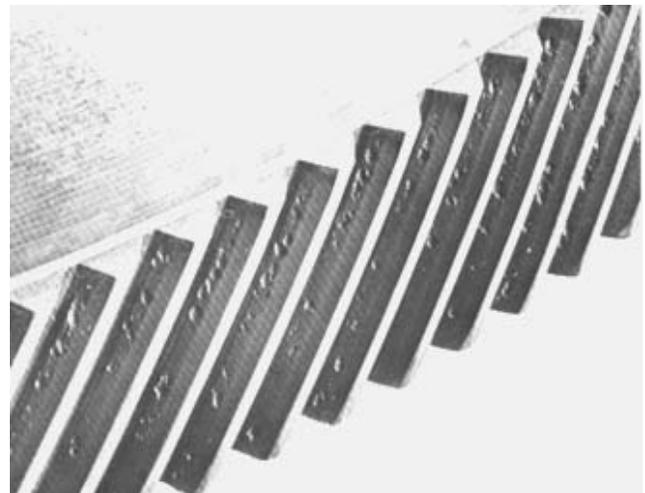
SPALLING is a term used to describe a large or massive area where surface material has broken away from the tooth. In through-hardened and softer material, it appears to be a massing of many overlapping or interconnected large pits in one locality. See **Figures 2.15** and **2.16**. In surface hardened material it manifests itself as the loss of a single or several large areas of material. The visual pit like attributes are not observed, see **Figure 2.17**. Frequently the bottom of the spall appears to run along the case-core interface.

FIG. 2.15 (13-162) SPALLING (THRU HARDENED GEAR)

Spalling is caused by high contact stresses possibly associated with proud areas of the tooth surface. With surface-hardened gear teeth, surface or subsurface defects or excessive internal stresses from improper heat treatment also can cause spalling.

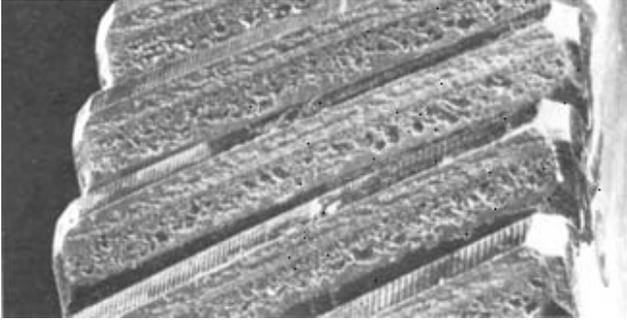
FIG. 2.16 (2342-7C) SPALLING (THRU HARDENED GEAR)

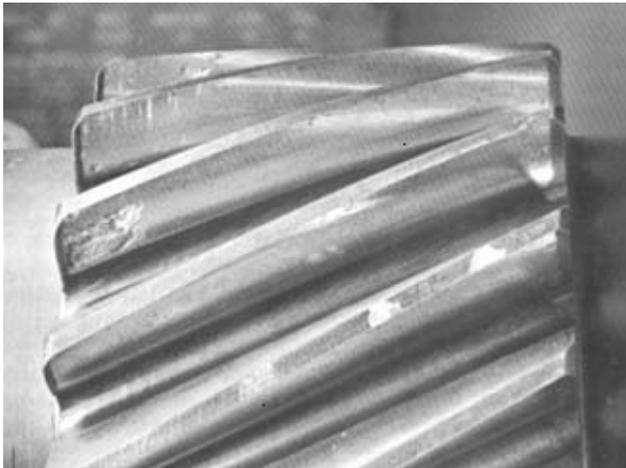
FIG. 2.17 (828-2) SPALLING (SURFACE HARDENED GEAR)

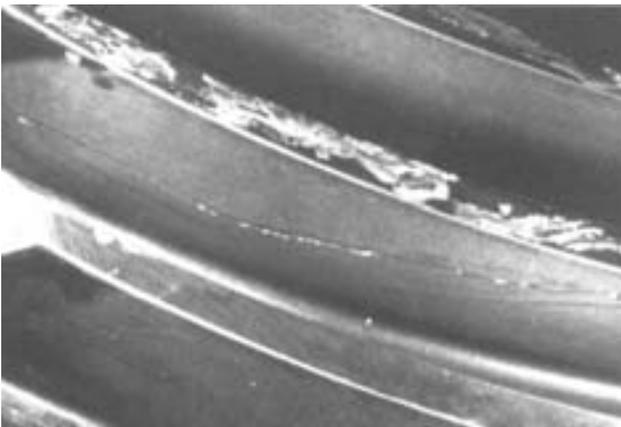
CASE CRUSHING is another form of spalling associated with heavily loaded case-hardened gears. It appears as long longitudinal cracks on the tooth surface which may subsequently break away. It often occurs suddenly, without

FIG. 2.18 (2342-8C) CASE CRUSHING

warning signs, on only one or two teeth of the pinion or gear. The cracks differ from those of pits in that they not only extend below the hard case, but most of its depth is in the softer core material. The cracks in the case, generally are perpendicular to the surface. Figure 2.18 shows an example of this failure mode. Failure may be due to insufficient case depth, insufficient core hardness or high residual stresses or too high loading.

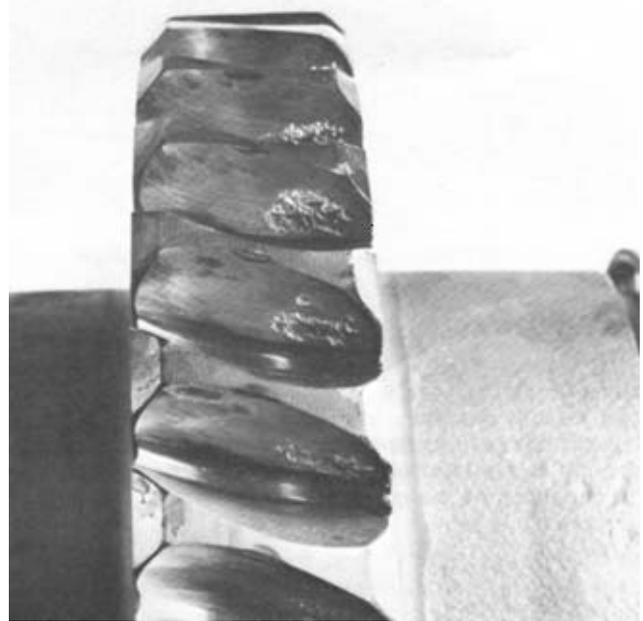
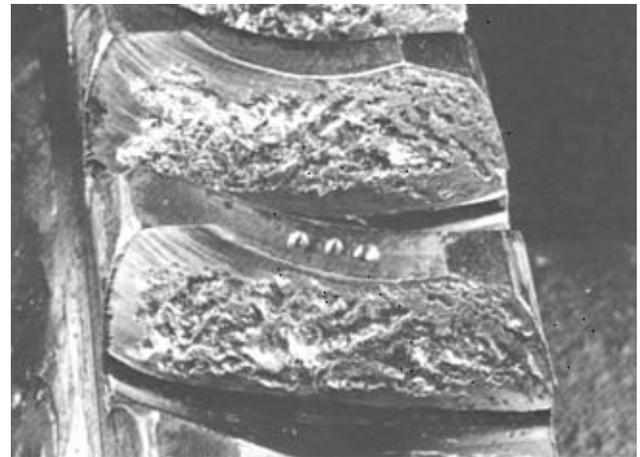
FIG. 2.19 (1169-16) WORM GEAR PITTING)

FIG. 2.20 (596-2) WORM GEAR PITTING)

WORM GEAR endurance tests have been performed by Falk during the past several years. The tests have run to approximately 20,000 hours and from these tests varying degrees of surface destruction may be severe when compared with that of a helical gear, the worm gears nevertheless survived the test. From this experience we can conclude that worm wheels incurring this amount of destruction can still perform satisfactorily. **Figures 2.19 and 2.20** illustrate this surface deterioration.

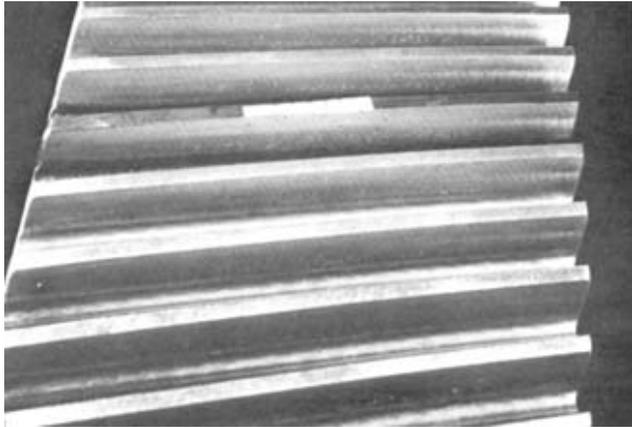
POLISHING OR LIGHT WEAR, **Figures 2.21** and **2.22** is the slow loss of metal at a rate that will little affect satisfactory performance of the gears within the life of the gears. It is a normal, very slow wear-in process in which asperities of the contacting surfaces are gradually worn until very fine, smooth, conforming surfaces develop. Polishing or light wear can occur by either abrasive or adhesive mechanisms when thin oil films or what is known as boundary lubrication conditions prevail usually on slow speed applications.

FIG. 2.21 (697-7) INITIAL PITTING AND LIGHT WEAR

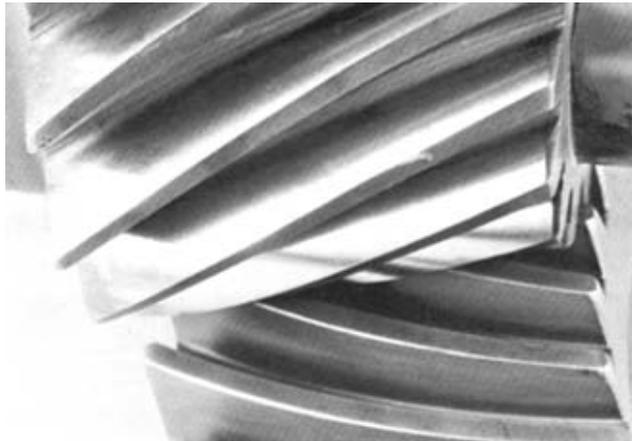
FIG. 2.22 (2342-9C) POLISHING (SURFACE HARDENED GEAR)

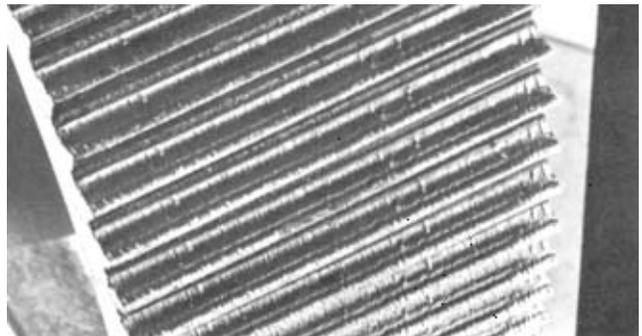
FIG. 2.24 (747-1) EXCESSIVE WEAR

EXCESSIVE OR DESTRUCTIVE WEAR, see **Figure 2.24**, is surface destruction that has changed the tooth shape to such an extent that smoothness of meshing action is impaired and life is appreciably shortened. Continued operation results in still greater wear and may eventually lead to tooth breakage.

The occurrence of such wear early in the operational history, can be caused by excessive loads, contaminated oil or too light an oil viscosity. Excessive wear incurred over a long period of operational history would be considered an advancement of normal wear from the moderate to the excessive degree and may not be detrimental to the operation of the gear drive.

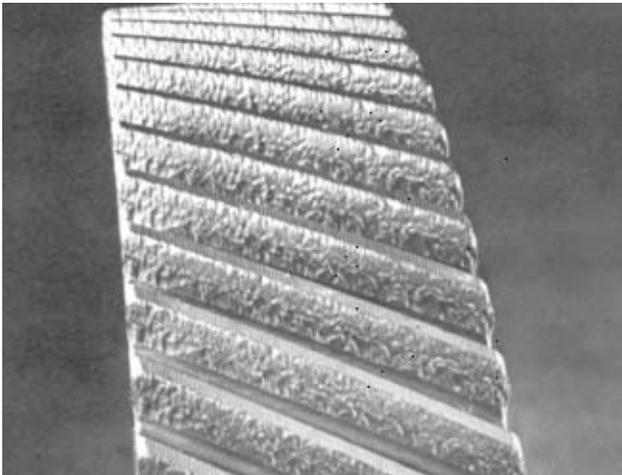
ABRASIVE WEAR, sometimes called cutting wear occurs when hard particles slide and roll under pressure, across the tooth surface. Hard particle sources are: dirt in the housing, sand or scale from castings, metal wear particles from gear teeth or bearings, particles introduced into housing when filling with lube oil and particles infiltrating into unit in service. **Figure 2.25** shows abrasive wear of a through-hardened gear caused by massive loss of hard surface material from tapered bearing surfaces. Gear teeth surfaces hardened after cutting sometimes have rough surface that may wear softer mating teeth. **Figure 2.26** shows through hardened teeth that were worn away in just a few hours from the flame-hardened teeth which had rough surfaces due to a sand blast cleaning operation.

FIG. 2.25 (942-3) ABRASIVE WEAR (THRU HARDENED GEAR)

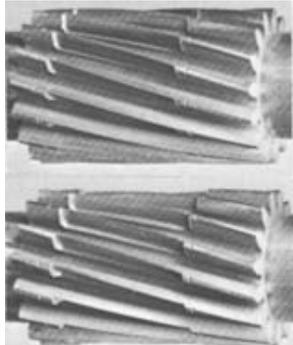
THRU HARDENED PINIONS(350-390 BHN
RUN AGAINST FLAME HARDENED GEARS

GEAR SANDBLASTED
5 HRS.
.025 WEAR

GEAR SANDBLASTED
50 HRS.
.070 WEAR

FIG. 2.26 (749-1) ABRASIVE WEAR (THRU HARDENED GEAR)

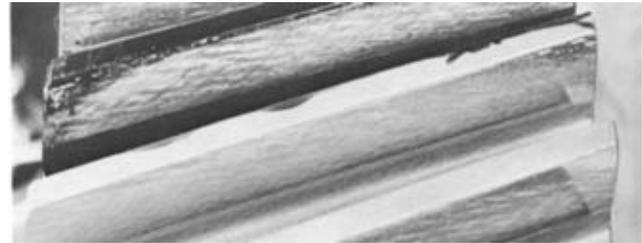
SCRATCHING is a form of abrasive wear, characterized by short scratch-like lines in the direction of sliding. This type of damage is usually light and can be stopped by removing the contaminants that caused it. **See Figure 2.27.**

FIG. 2.27 (2342-10C) SCRATCHING

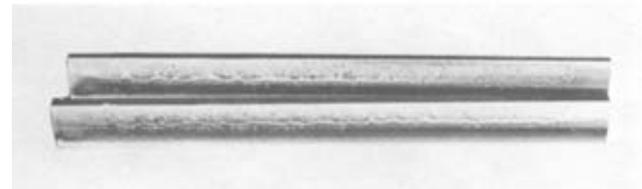
Adhesive wear depends upon the bond strength, which relates to the physical chemistry of the contact material and lubricant, on the load and on the material hardness. **Figures 2.28 and 2.29** show typical surfaces of through hardened and surface-hardened gears respectively that have undergone adhesive wear.

FIG. 2.28 (2342-11C) ADHESIVE WEAR (THRU HARDENED GEAR)

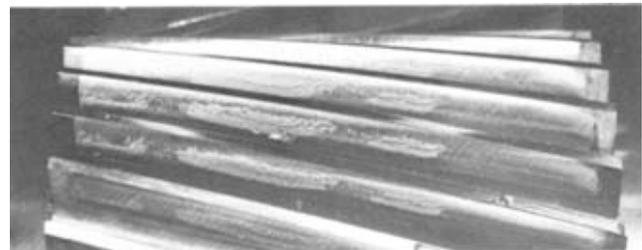
FIG. 2.29 (2342-12C) ADHESIVE WEAR (SURFACE HARDENED GEAR)

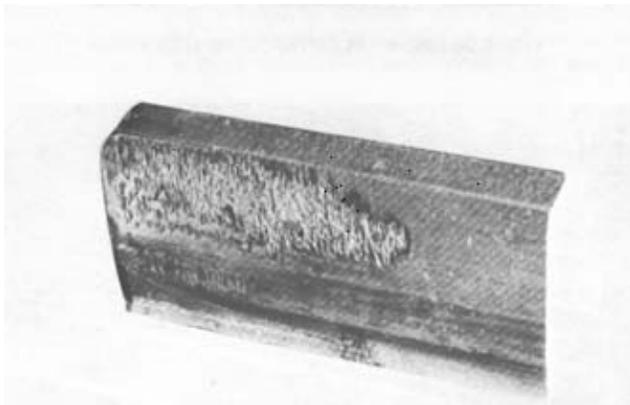
SCORING, **Figure 2.30**, is the smearing and rapid removal of material from the tooth surface resulting from the tearing out of small particles that become welded together as a result of oil film and high temperature metal-to-metal contact in the tooth mesh zone. After welding occurs, sliding forces tear the metal from the surface producing a minute cavity in one surface and a projection on the other. The wear initiates microscopically, however, it progresses rapidly.

Scoring most frequently occurs in localized areas on the tooth where high contact pressure exists or at the tip or root where sliding velocities, and hence contact temperatures, are high. This mode of wear is usually associated with high pitch line velocities and is not common in the lower hardness through-hardened gears running at normal commercial speeds.

The direct causes of scoring are high contact temperature and pressure and marginal lubrication. Scoring can sometimes be prevented by use of more viscous oil or by an EP type oil. Localize high contact pressure can be relieved by improved finishing of tooth surfaces. Sometimes profile or face modifications are required on highly loaded teeth to minimize high localized pressures.

FIG. 2.30 (683-1) SCORING

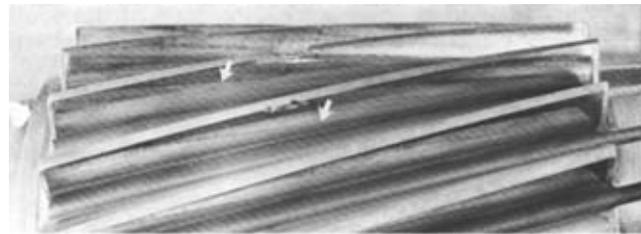
WAVY TOOTH WEAR is occasionally observed on gears. Teeth can be observed to have wavy or undulating surfaces either by light reflection or by profile and lead checks. The crests and valleys of the waves usually lie parallel to the inclined lines of helical contact. See **Figure 2.32**. This wear pattern is thought to be caused by vibratory loads occurring in the system in which the gears are operating.

FIG. 2.32(2342-13C) WAVEY TOOTH WEAR

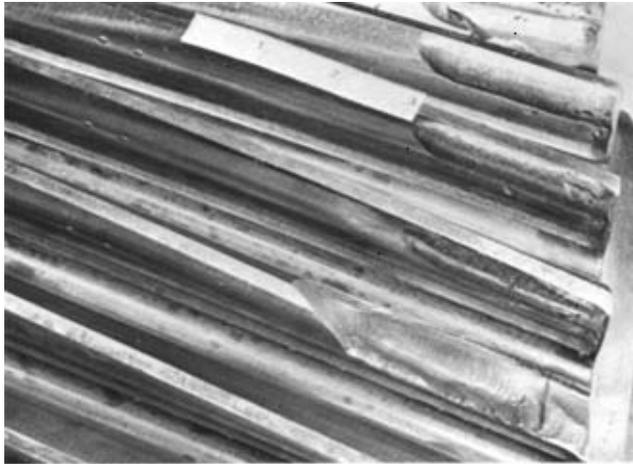
SURFACE BUMPS are occasionally experienced as shown in **Figure 2.33**. The cause of such phenomena has not yet been defined. As with welding, axial movement could cause localized high tooth pressures which could fracture teeth. The tooth surfaces should be dressed to remove proud bumps.

FIG. 2.33 (2342-14C) SURFACE BUMPS

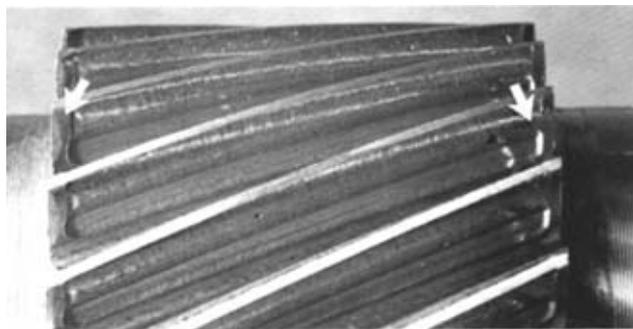
WEAR PADS. Pinion elements of a gear set are frequently made slightly wider than the gear element. As wear occurs, unworn pads are left at the tooth ends of the pinion, **Figure 2.34**. These cause no problem as long as axial positioning of gears is properly maintained. If unit is disassembled for some reason and subsequently reassembled, these pads on the ends of the pinion should be ground flush to the worn surface to assure that heavy contact, and possible tooth fracture, does not occur from this source.

FIG. 2.34 (2342-15C) WEAR PADS

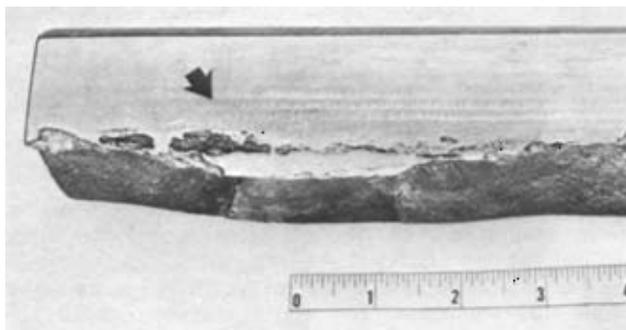
FURROWING has been observed on the working tooth surfaces of coarse textured, low DP, “as hobbed” mill pinion teeth shortly after being put into service. To the unaided eye, it appears as a lattice of fine hair lines oriented generally in the root-to-tip direction. They are aligned in rows across the face of the tooth in an order consistent with the hobbing texture pattern, see **Figure 2.35**.

FIG. 2.35 (2342-16C) FURROWING

The cause of furrowing has not been definitely established. Under the microscope, they appear as round bottom channels looking as if they were formed by hydraulic erosion. At present there are no recognized problems emanating from furrowing. It is thought to be prevented by minimizing localized contact pressure and by maintaining adequate lube films.

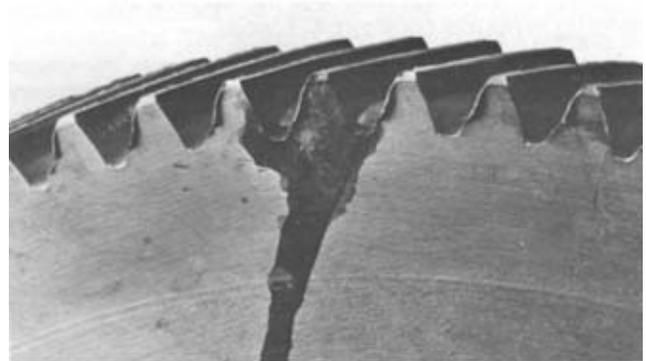
COLD FLOW occurs when the surface and subsurface material show evidence of metal flow. Often surface material has been worked over the tips and ends of the gear teeth, giving a finned appearance. See **Figure 2.36**. This is sometimes called **ROLLING** or **WIRE EDGING**. Sometimes the tooth tips are heavily rounded-over and a depression appears on the contacting tooth surface. **PEENING**, another form of plastic flow as shown in **Figure 2.37**, is caused by excessive loading due to impact loading.

FIG. 2.36 (683-6) PLASTIC FLOW (ROLLING)

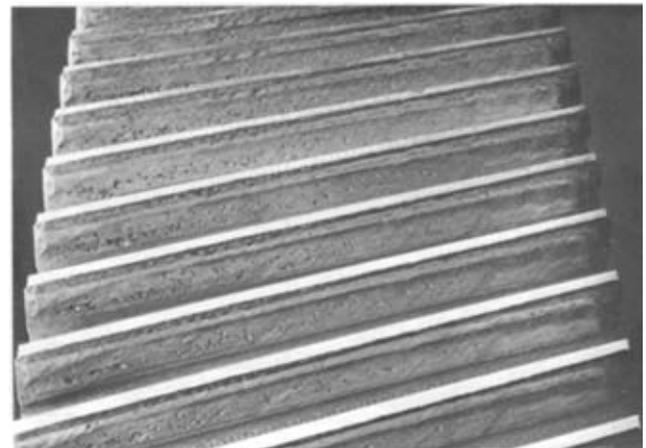
FIG. 2.37 (683-11) PLASTIC FLOW (PEENING)

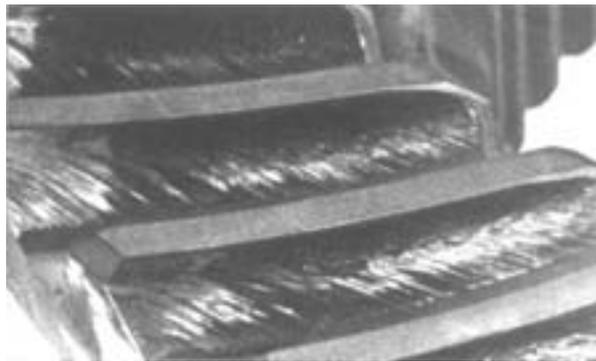
RIDGING is the formation of deep ridges by either wear or plastic flow of surface and subsurface material, **Figure 2.39**. It shows definite peaks and valleys or ridges across the tooth surface in the direction of sliding. Ridging is caused by wear or plastic flow of surface and subsurface material due to high contact compressive stresses and low sliding velocities. It is often present on heavily loaded worm and worm gear

FIG. 2.39 (2342-18C) RIDGING

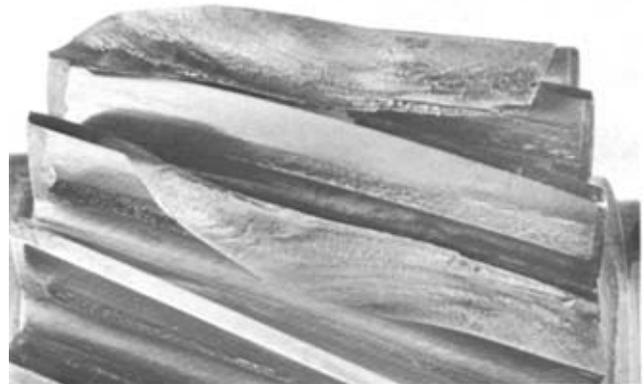
CLASSICAL TOOTH ROOT FILLET FATIGUE FRACTURE is the most common fatigue breakage mode. It is illustrated in **Figure 2.40**. The crack originates at the root fillet on the tensile side of the tooth and slowly progress to complete fracture either along or across the tooth. The face of these fractures are usually characterized by a series of contour lines or "beach marks" caused by the progressing crack "front". They indicate the position of the advancing crack front at a given time. As the section gradually weakens, the crack progresses further with each load cycle and the beach marks become more coarse. The focal point of these marks often locates the origin of the fracture.

FIG. 2.40 (683-5) TOOTH FRACTURE (ROOT FILLET FATIGUE)

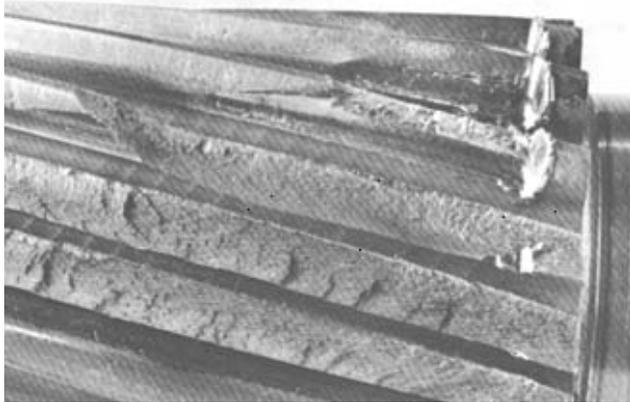
LOW CYCLE FATIGUE OR IMPACT FRACTURES are due to a low number of high load fatigue cycles or to a single very high load. **Figure 2.41** illustrates such fractures. With lower hardness, more ductile materials, the fracture face is coarse, fibrous and torn in appearance. With harder, less ductile material, the appearance may be smooth or silky looking.

FIG. 2.41 (683-7) TOOTH FRACTURE (LOW CYCLE FATIGUE)

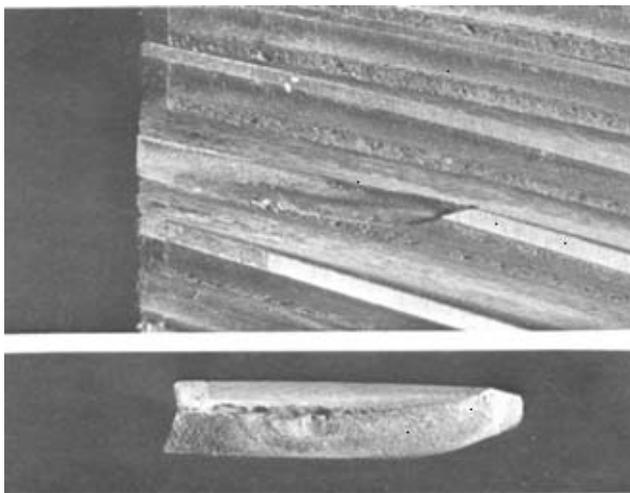
PIT ASSOCIATED FRACTURES occasionally originate in severely pitted areas since pits can act as stress raisers and can be crack origins. **Figure 2.42** illustrated such a fracture.

FIG. 2.42 (697-9) FATIGUE FRACTURE EMANATING FROM PIT

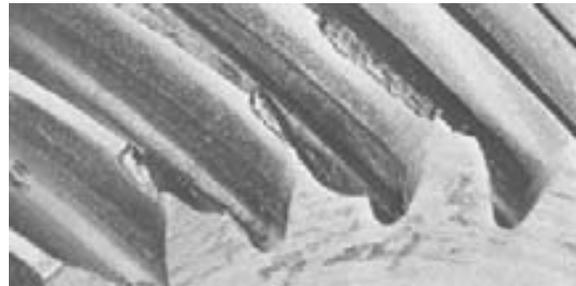
TOOTH TIP CHIPPING is a fracture mode where the top of a tooth will break away from lower portion, see **Figures 2.43 and 2.44**. Failures of this kind may be caused by deficiencies in the gear tooth, which results in a high stress concentration at a particular area. Sometimes flaws or minute grinding cracks will propagate under repeated stress cycling and a fracture will eventually develop. Foreign material passing through the gear mesh will also produce short-cycle failure of a small portion of a tooth. High residual stresses due to improper heat treatment can cause local fractures that do not originate in the tooth root section.

FIG. 2.43 (2342-19C) TIP CHIPPING (THRU HARDENED GEAR)

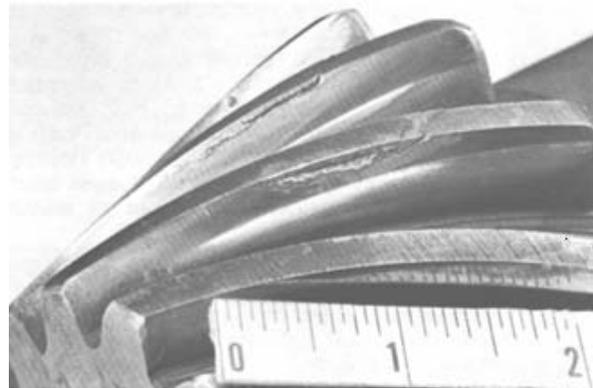
FIG. 2.44 (2342-20C) TIP CHIPPING (SURFACE HARDENED GEAR)

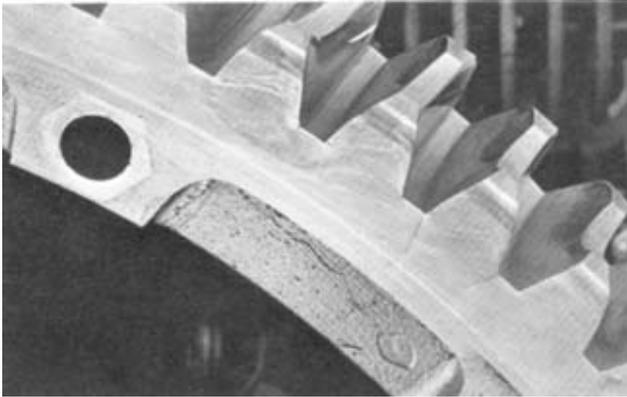
WORM WHEEL FRACTURES are occasionally encountered. **Figure 2.45** shows a tooth root-rim fracture on a bolt-on type worm wheel. Such failures are rare and are indicative of overloading.

FIG. 2.45 (2342-21C) WORM WHEEL TOOTH FRACTURE

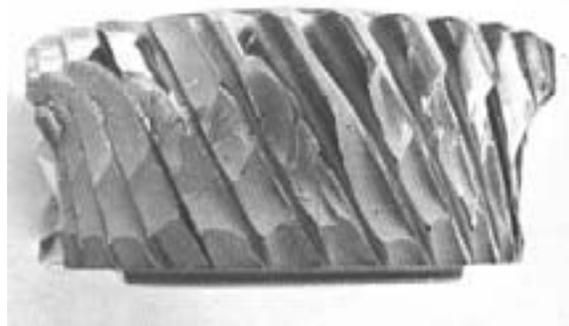
FRACTURE DUE TO FAILURE OF ASSOCIATED PARTS. Sometimes a severe load maldistribution of load on gear teeth can occur from damage to associated parts. **Figure 2.46** illustrates a pinion run for a time after a severe bearing failure. Load shifted to one end of the teeth and they subsequently broke away. The process repeated itself two more times before the element was finally removed from service. Similar fractures could occur from shaft that is severely bent or broken.

FIG. 2.46 (683-14) TOOTH FRACTURE FROM BEARING FAILURE

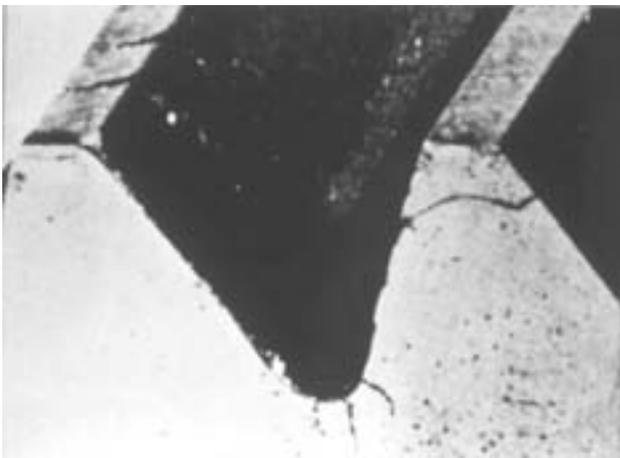
QUENCHING CRACKS can develop with some materials during heat treatment and after quenching of the gear blank in a quenching medium. Often these cracks are visible to the naked eye, **Figure 2.47**. They may run across the top land of the tooth or be radial in direction at the ends of the teeth. When these are found, the material and heat treat specifications should be reviewed and the processing procedures reexamined.

FIG. 2.47 (2342-22C) QUENCH CRACKS (THRU HARDENED MATERIAL)

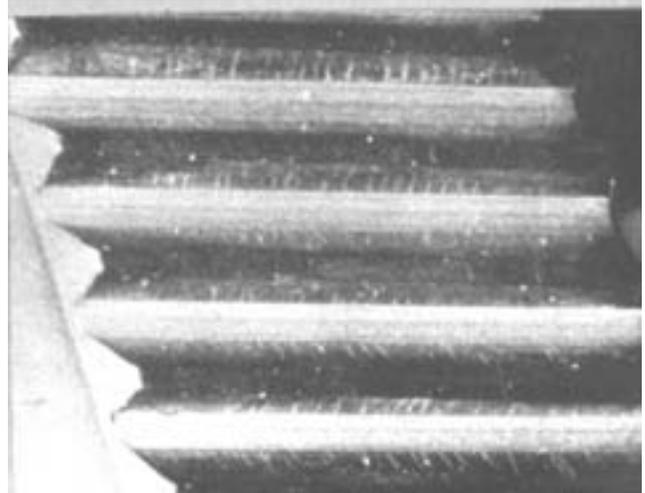
Sometimes grinding cracks are latent and do not show up until after several hours of shelf life or after operation under load. When found an examination of the processing procedures is in order.

FIG. 2.48 (2342-23C) GRINDING CRACKS (ENLARGED)

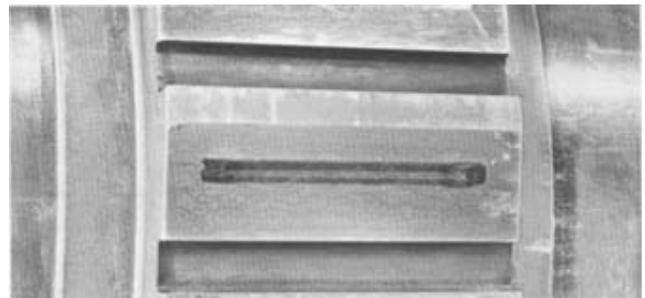
FIG. 2.49 (2342-24C) GRINDING CRACKS

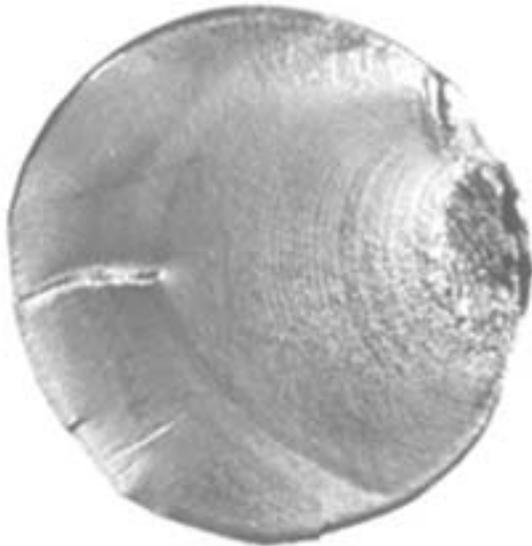
In general, fractures resulting from bending stresses are perpendicular to the shaft axis, see **Figure 3.1**, whereas fracture resulting from fatigue type torsional stresses most frequently are disposed at a 45° angle to the shaft axis, see **Figure 3.2**.

FIG. 3.1 (2342-25C) BENDING FRACTURE

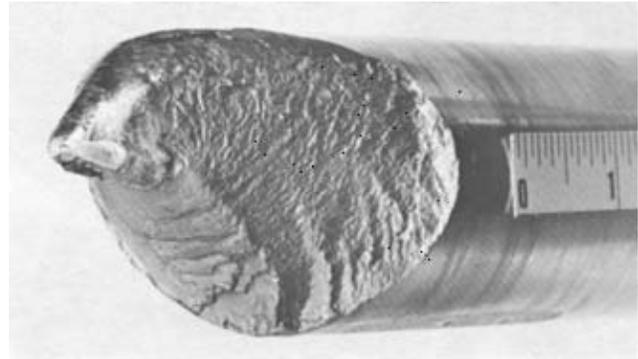
FIG. 3.2 (2342-26C) TORSIONAL FRACTURE

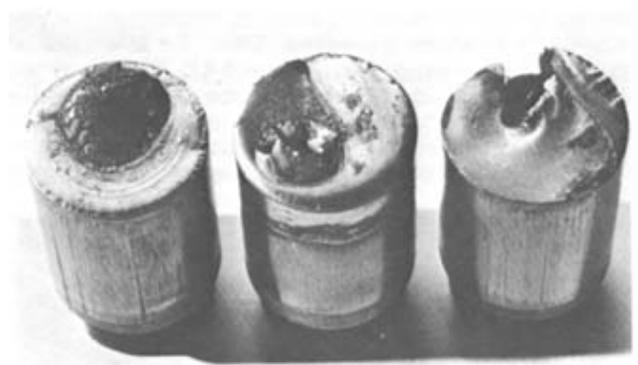
Figure 3.3 illustrates three types of shaft fractures. The one on the left resulted from bending fatigue due to a high stress raiser at a fillet. Note the many ratchet marks around the periphery at the fillet location indicating multiple crack starts. The fracture of the center shaft was due to bending fatigue, essentially having started at one location and propagating to shaft center when final fracture occurred. The fracture of the shaft shown on the right was primarily due to torsional fatigue originating at the left of the keyway. This crack propagated in the counterclockwise direction, but final fracture, to the right of the keyway was caused by bending. The small area of the final fracture zone indicates that the nominal stress was low.

FIG. 3.3 (548-7) SHAFT FRACTURES

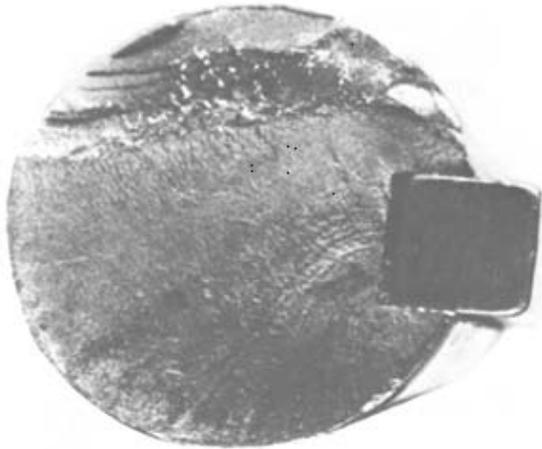
KEYS AND KEYWAYS. Some fatigue fractures start from a combination of stress raisers such as a keyway and the end of a key. **Figure 3.4** shows such a failure. The strength of a keyed joint is affected by the distribution of the load along the keyway. The strength of the shaft at the keyway depends on position of the key in the hub, the accuracy of the key and the keyway, the geometric shape of the end of the keyway and the location relative to shaft shoulder fillets and the magnitude of the interference fit.

FIG. 3.4 (548-1) SHAFT FRACTURE (KEY AND KEYWAY ASSOCIATED)

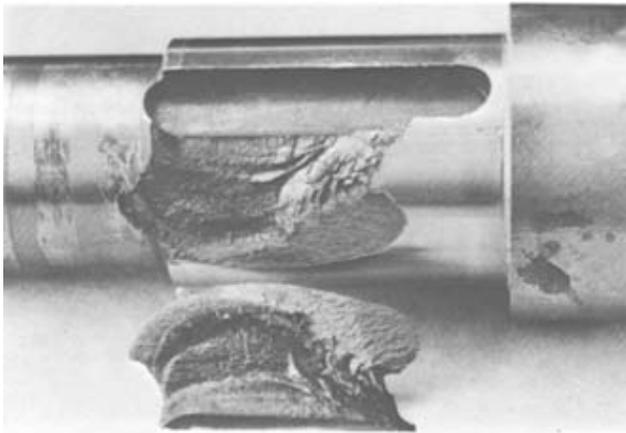
FIG. 3.5 (548-6) SHAFT FAILURE (PEELING)

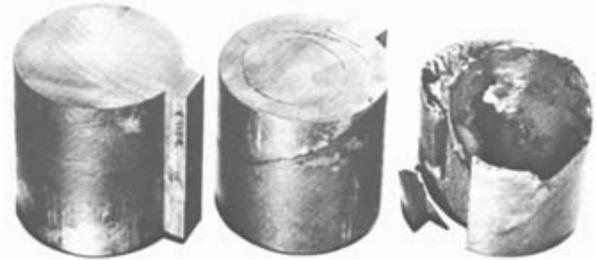
FIG. 3.6 (548-5) SHAFT FRACTURES

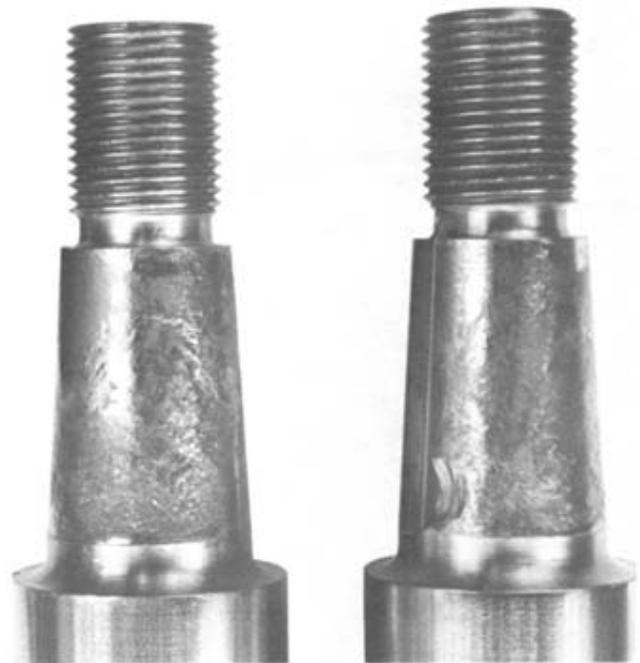
FRETTING CORROSION occurs where minute relative movement of tightly fitted parts occurs such as at bearing, gear and coupling hub seats. As fretting progresses, minute cracks form at the surface of the shaft which form stress raisers which can become origins for fatigue cracks. **Figure 3.7** illustrates such a situation. Fits must be designed properly and manufactured accurately to assure proper fit pressure to prevent fretting. On taper bore fits, locknuts which hold the gear in place must be properly torqued.

FIG. 3.7 (2342-27C) FRETTING CORROSION

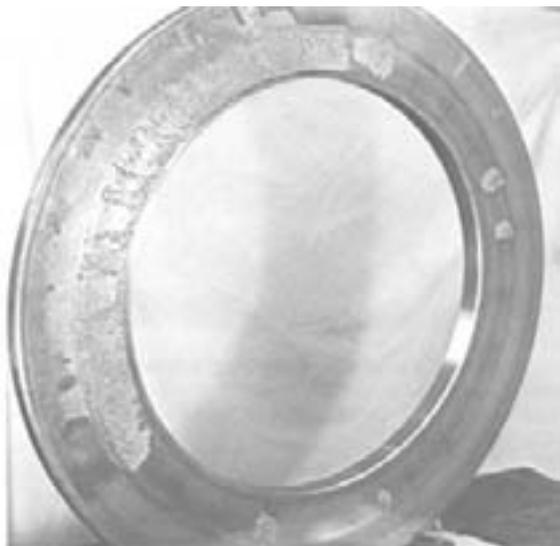
A bearing can be failed before it is placed into service, if the unit in which it is mounted is improperly stored prior to installation. The damage done to a bearing due to corrosion manifests itself by a surface that appears to be stained. Under magnification, this area contains a series of pits which serve as a nucleus for a spall which leads to a complete failure shortly after the unit is placed in service. **Figure 4.1** which is the race of a large thrust bearing illustrates this type of failure. If a spalled bearing race is not excessively damaged, it is possible to get a clue as to whether corrosion was the basic cause by noting if the spalled areas are spaced approximately the same as the roller spacing. In **Figure 4.1** note the definition of the roller spacing.

FIG. 4.1 (2342-28C) FAILURE INDUCED BY CORROSION

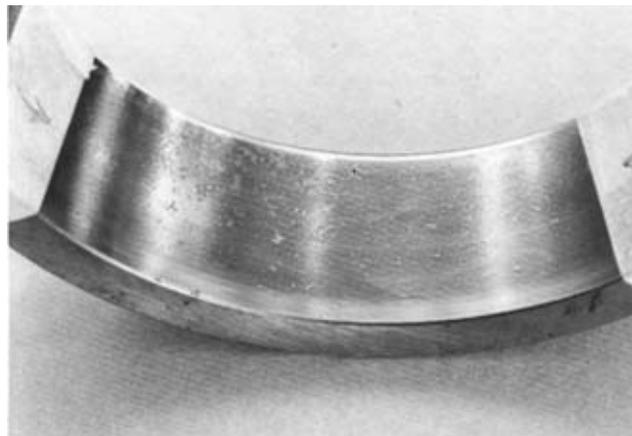
FIG. 4.2 (2342-29C) DEBRIS DENTING

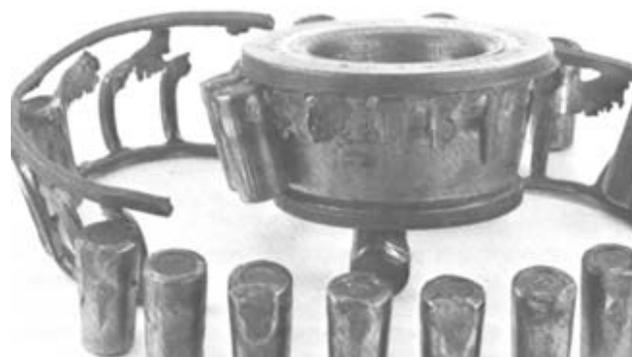
FIG. 4.3 (2342-30C) WELDING OF ROLLERS

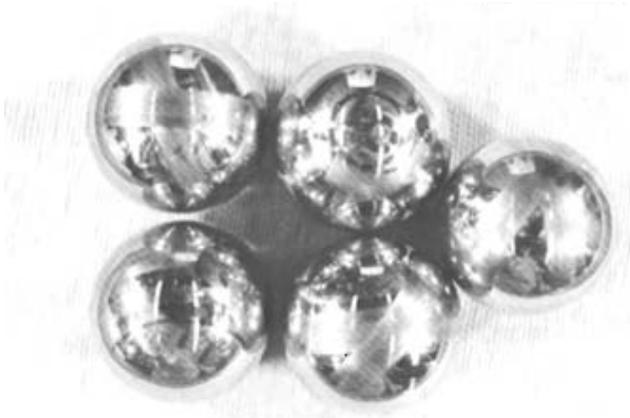
FIG. 4.4 (2342-31 C) BALL BANDING

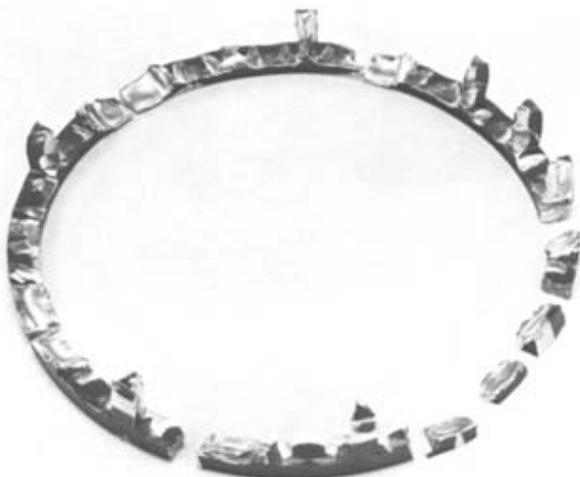
FIG. 4.5 (2342-32C) CAGE BREAKAGE

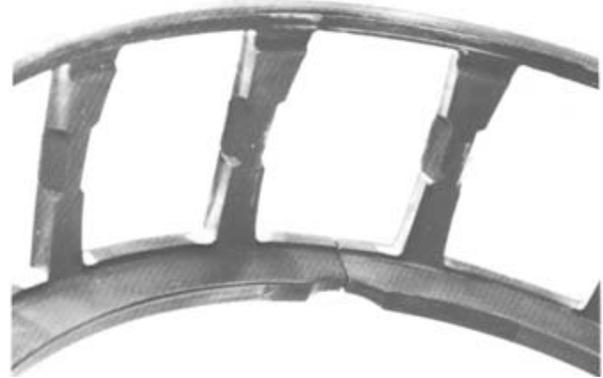
FIG. 4.6 (2342-33C) CAGE BREAKAGE AT NOTCH AND REDUCED SECTION

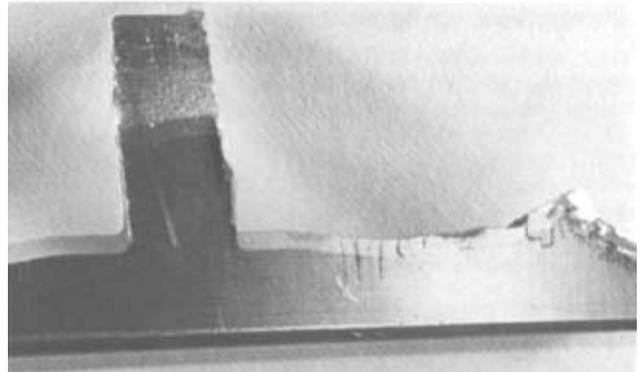
FIG. 4.7 (2342-34C) CRACKS IN CAGE FROM NOT REMOVING SHARP EDGE

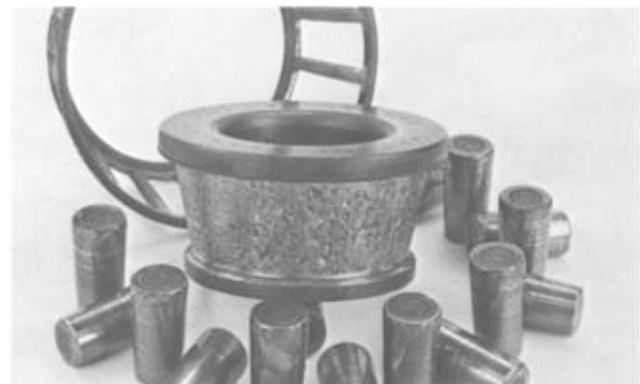
FIG. 4.8 (2342-35C) CAGE WEAR AND ROLLER END WEAR

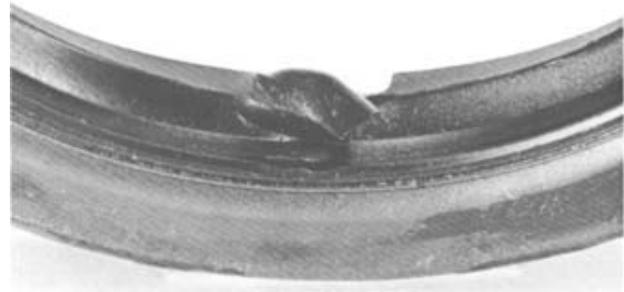
FIG. 5.2 (2342-37C) CUT AND TURNED UNDER LIP

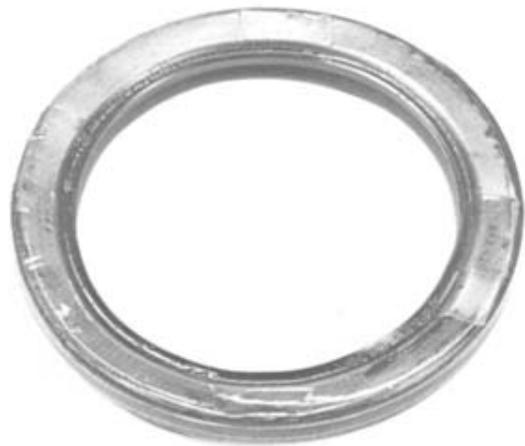
FIG. 5.3 (2342-38C) DAMAGED SEAL CASE

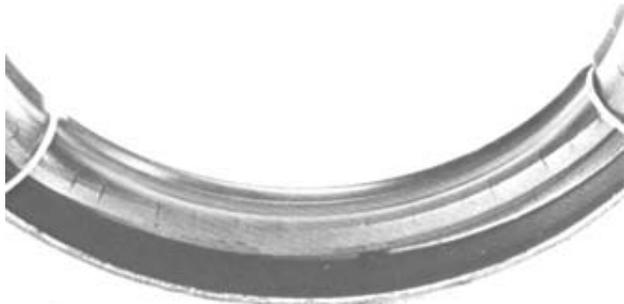
FIG. 5.4 (2342-39C) HEAT CRACKING

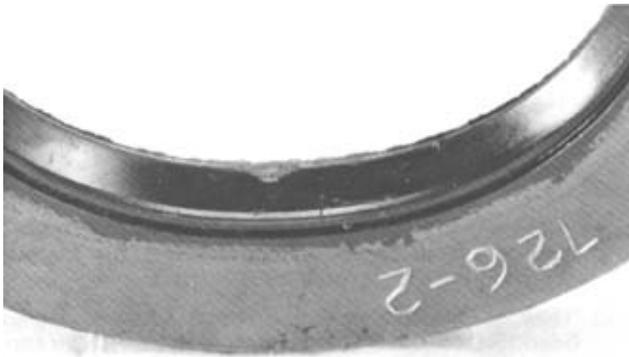
FIG. 5.5 (2342-40C) CHIPPING OF SEAL LIP

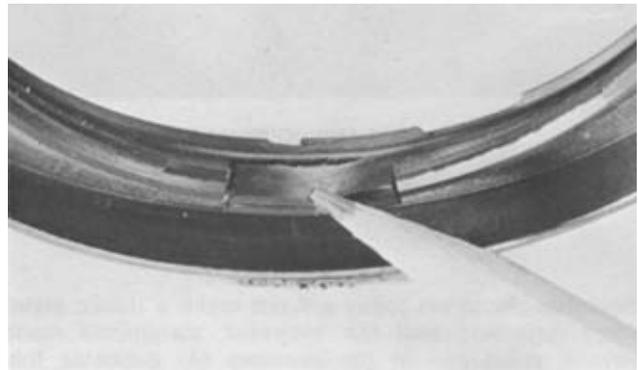
FIG. 5.7 (2342-42C) RADIAL AND CIRCUMFERENTIAL CRACKS DUE TO OZONE

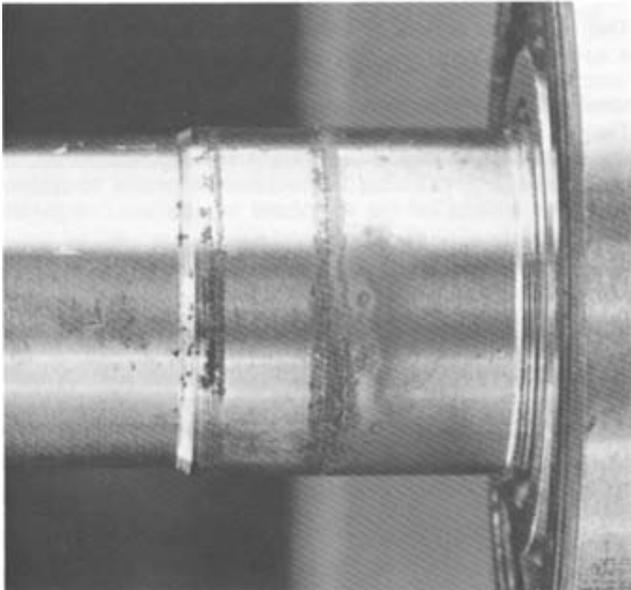
FIG. 5.8 (2342-43C) JOURNAL WEAR
