I. PURPOSE

Monitoring and inspection of the Thomas disc pack in the field.

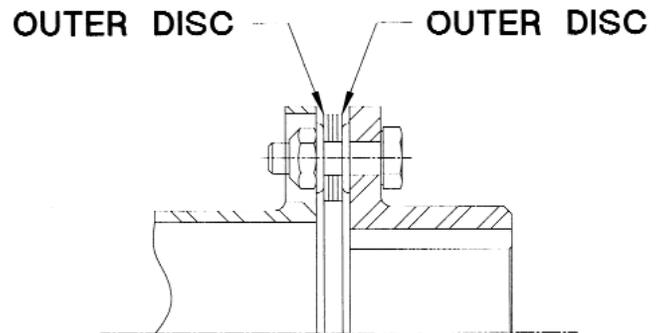
FIGURE 1

The Thomas disc coupling is easily inspected. Visual analysis may point to possible drive system problems. Proper evaluation of the disc packs and connecting parts may save considerable maintenance costs and downtime. When a disc coupling starts to fail, it is usually from the outer disc of the laminated pack and progresses towards the center of the pack. See figure 1.

Because of this progression, the deterioration of the coupling disc pack may be detected before ultimate failure.

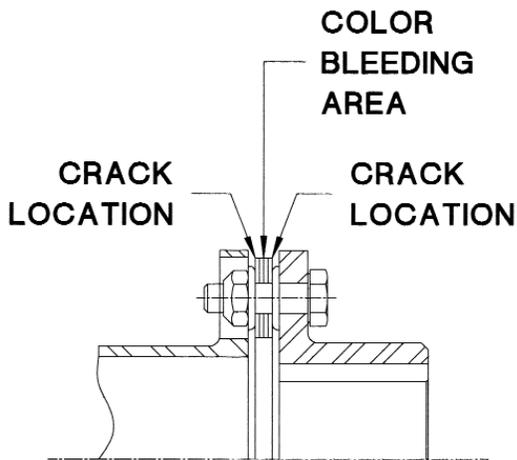
FIGURE 2

1. Reddish brown color bleeding out between disc laminations at the O.D. of the pack. This is an indication of fretting and/or chemical attack of the disc material. See Figure 2.

2. Fine line crack starting in the outer disc, tangent to the washer O.D. This is an indication of misalignment and can be seen by looking at the outside edge of the disc pack. See Figures 2, 8 and 9.

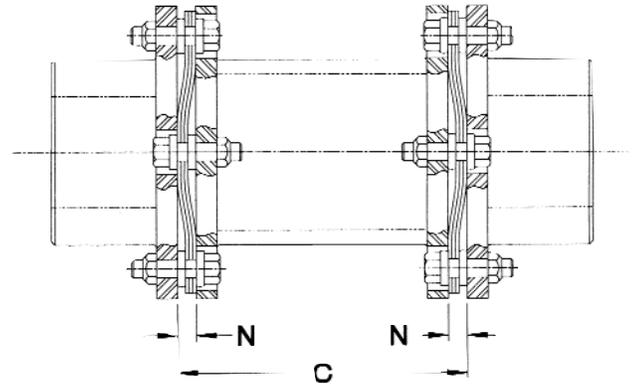
FIGURE 3

3. Disc pack is wavy and dimension between flange faces "N" is smaller than indicated in the installation instructions or applicable assembly drawing. See Figure 3. This indicates that the coupling has been installed in a compressed condition or equipment has shifted axially during operation. Check for shaft thermal growth conditions. Realign axial position of equipment so the coupling operates with a neutral, flat disc pack.

COMPRESSION

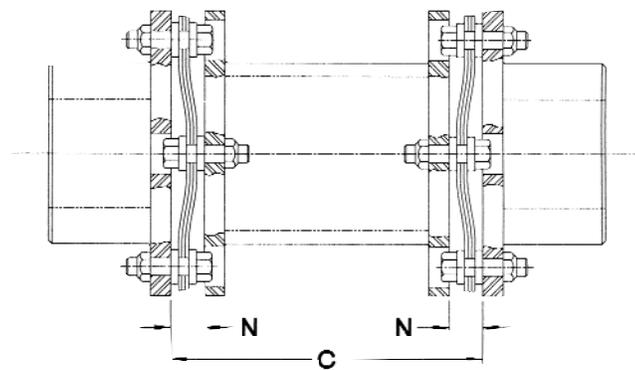
FIGURE 4

4. Disc pack is wavy and dimension between flange faces "N" is larger than specified on installation instructions or applicable assembly drawing. See Figure 4. This indicates that the coupling has been installed in an elongated position or equipment has shifted axially during operation. Realign axial position of equipment so coupling operates with a neutral, flat disc pack.

ELONGATION

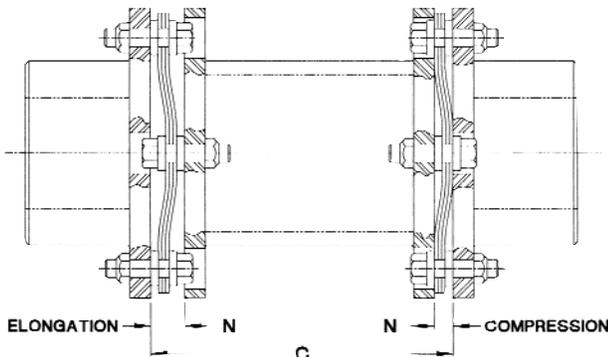
FIGURE 5

5. Disc packs (both ends) are wavy. One end is compressed, and the other end is elongated. (See Figure 5). The conditions can be reversed by moving the center member towards the elongated end. This is called "oil canned" disc packs. The disc pack has no neutral center where it remains flat and parallel with the end flanges.

OIL CAN

This condition can be the result of:

- 1) Tightening the disc pack locknuts while the disc packs are in the compressed or elongated coupling position. See Figure 3 and/or 4.
- 2) Tightening of disc pack locknuts while coupling is misaligned or other end of spool is hanging unsupported.
- 3) Bound up bolt(s) in the bolt hole(s).
- 4) Damaged discs which could be caused by abnormal running conditions, misuse, or loose bolts.

To correct "oil canned" disc pack:

- 1) Loosen all the disc pack locknuts. Correct the axial spacing of the coupling as necessary with the coupling aligned and spacer fully supported. If "oil canned" conditions disappears, retorque locknut while coupling is in its neutral position.
- 2) If (1) above is not successful, determine that all bolts, with locknuts loose, can be turned by hand. If any bolts are tight, the bolt holes should be cleaned out by lightly reaming the flange so that the bolt turns by hand in the hole. Reassemble and torque the locknuts while coupling is in its neutral position.

- 3) If the discs in the pack are permanently deformed, replace the disc pack with a new one and reassemble the coupling. This permanent deformation could be caused by a severe torque overload, abnormal axial loads, or even loose bolts. The cause of the deformation must be corrected before restart.

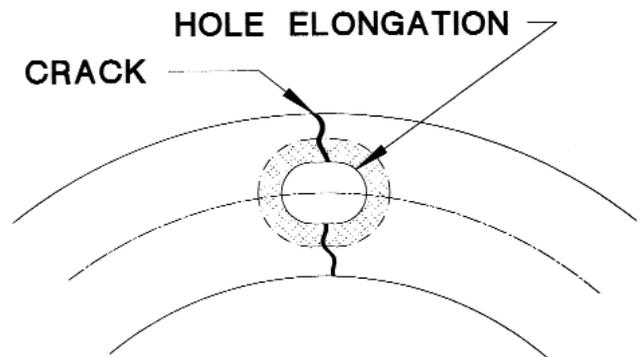
FIGURE 6

1. Disc broken through the bolt hole indicates loose coupling bolts. See Figure 5. Replace disc pack and tighten locknuts to specified torque value.

LOOSE BOLTS

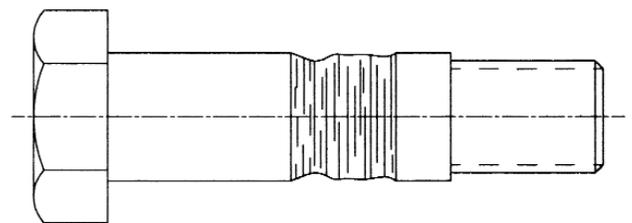
FIGURE 7

2. Discs embedded into bolt body are usually the result of a loose bolt or a severe torque overload. See Figure 7. Replace bolt and disc pack. Tighten locknut to proper torque. Do not torque the bolt as insufficient bolt stretch may occur.

LOOSE BOLTS

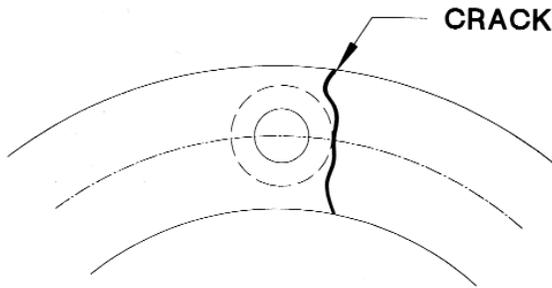
FIGURE 8

3. Disc broken adjacent to washer face usually indicates excessive shaft misalignment during operation. See Figures 1 & 8. This type of disc failure usually starts with outer disc and progresses through the disc pack. Realign equipment and replace both disc packs. Make hot check of alignment to assure it is within coupling misalignment capacity.

EXCESSIVE MISALIGNMENT

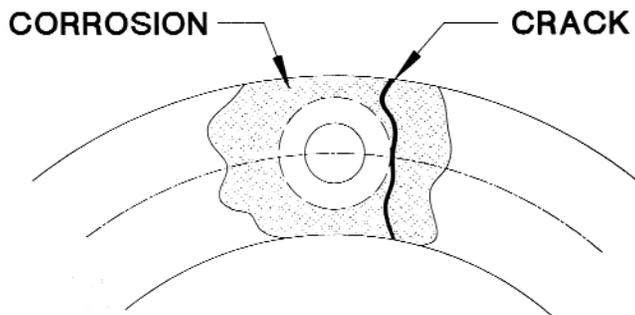
FIGURE 9

4. Disc broken adjacent to washer face with fretting corrosion present in the area of crack usually indicates excessive shaft misalignment during operation. Also, iron oxide will most likely be evident on outside of disc pack. See Figures 2 & 9. This is sometimes associated with a coupling that has been in service for several years and/or operating in a corrosive atmosphere. Breaks will first appear in outer discs and progress through the disc pack. Replace both disc packs and realign the equipment. Different disc pack material may also be considered.

**EXCESSIVE MISALIGNMENT
WITH CORROSION**

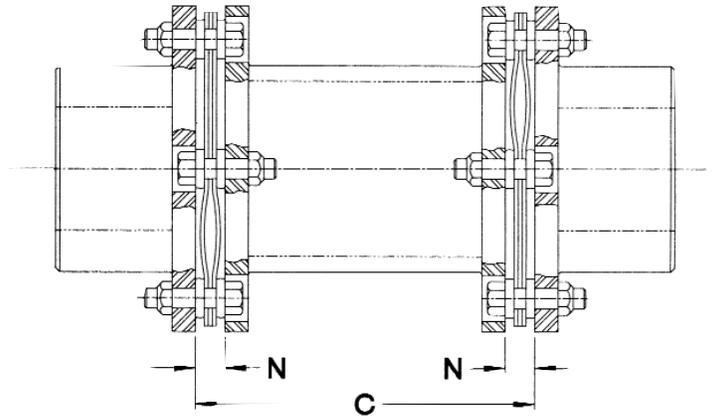
FIGURE 10

5. The disc pack has a bulge near the center or is bowed toward one flange in alternate chordal sections. See Figure 10. This condition is a result of a large torque overload, induced into the system, beyond the peak overload capacity of the coupling. The remaining disc pack chordal sections will be straight and tight. This indicates improper coupling selection or a momentary system torque overload. If bulged or bowed conditions appears in one chordal section only, there may be a loose bolt on one side of the distortion. Loosen all coupling locknuts and unseat the bolts. The bulge should release and flatten out. Retorque locknuts. If distortion does not disappear, replace disc pack and retorque locknuts.

TORQUE OVERLOAD
