FAILURE ANALYSIS GEARS-SHAFTS-BEARINGS-SEALS

CONTENTS

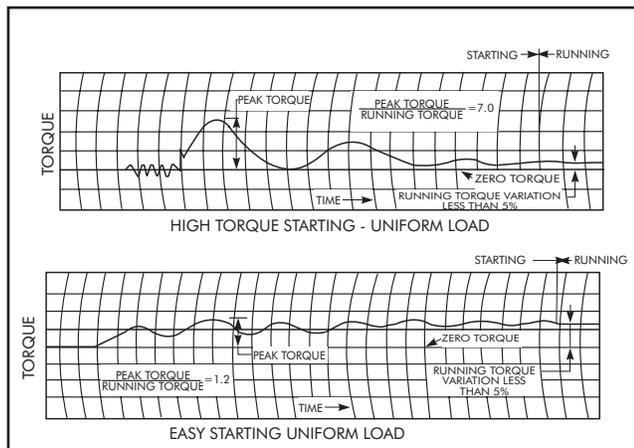
FIG. 1.1 (253-2) TORQUE METER RECORD

Momentary or transient peak loads are of such short duration that electrical meters do not respond accurately to them. In such cases torquemeter readings of instantaneous loads, as shown in **Figure 1.1** may be necessary to determine actual torque loads.

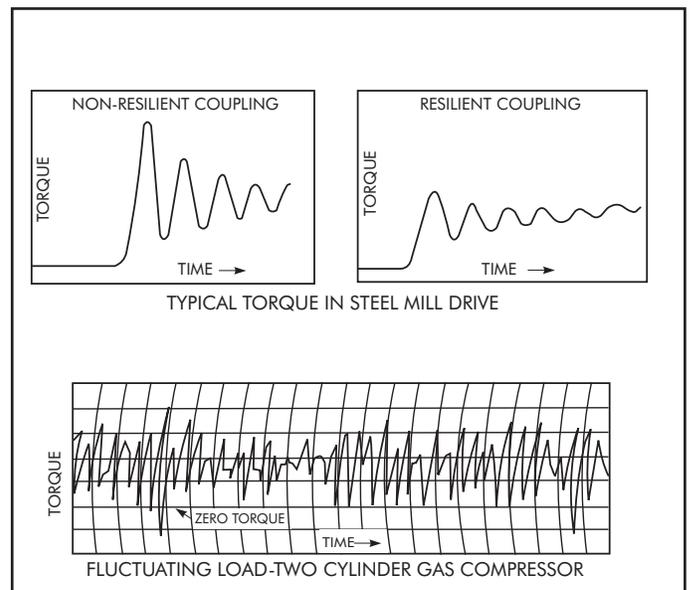
FIG. 1.2 (253-1) TORQUE METER RECORD

Vibratory loads, or system dynamic loads depend on the interrelation of the components in the entire system with one another and torque readings or a study of the system is required to assess instantaneous loads. From properly obtained torque readings, see **Figure 1.2**, the load characteristics of the system can be determined including steady state loads, peak loads, accelerating loads, reversing and vibratory loads and other dynamic effects that may exist. Once the nature of the load within a system has been established, the manner in which the load affects each of the drive components must then be assessed.

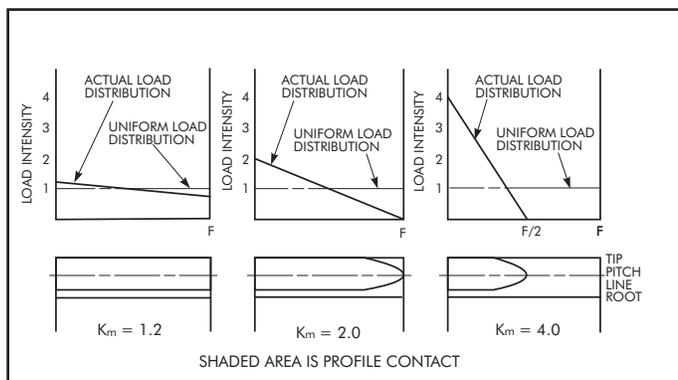
FIG. 1.3 (253-3) CONTACT PATTERNS AND LOAD DISTRIBUTION

tolerances result in loads being non-uniformly distributed across the gear tooth surface, thus stressing some areas of the tooth more highly than others. In the AGMA rating formulas, which are in wide use today, this effect is recognized by the incorporation of a load distribution factor, designated C_m or K_m . The numerical value of this factor is the ratio of the maximum load intensity on the tooth to the load intensity for a uniformly distributed load. **Figure 1.3** shows several contact patterns that might be observed on loaded teeth. Load intensity diagrams along with values of load distribution factors are shown for each case. Other more complex intensity distributions often prevail, but for most well designed gear sets, the load distribution factors vary from 1.2 to 1.7.

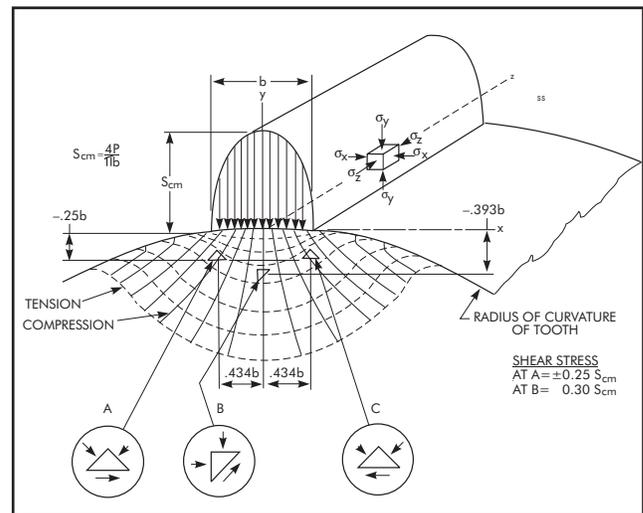
FIG. 2.1 (312-10) HERTZIAN STRESSES

Surface fatigue is the failure of a material as a result of repeated surface or sub-surface stresses beyond the endurance limit of the material. **Figure 2.1** indicates the theoretical mutual Hertzian stresses occurring when a gear and pinion mesh. There are compressive stresses at the surface and unidirectional and bi-directional sub-surface shear stresses. **Figure 2.2** indicates the magnitude of these stresses.

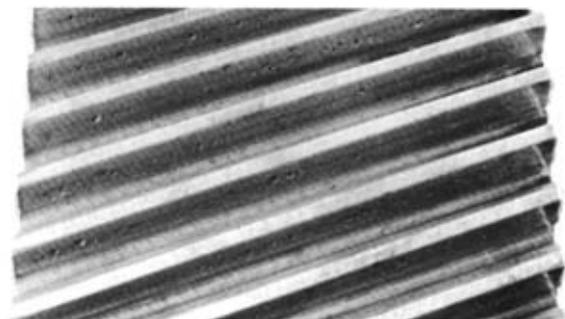
FIG. 2.5 (697-4) INITIAL (CORRECTIVE) PITTING

INITIAL PITTING is caused by local areas of high stress due to uneven surfaces on the gear tooth. This type pitting can develop within a relatively short time, reach a maximum and with continued service polish to a lesser severity. Initial pitting shown in **Figure 2.3** usually occurs in a narrow band at the pitchline or just slightly below the pitchline. It is most prominent with through-hardened gears and is sometimes seen with surface-hardened gears.

For most through-hardened industrial type gears, initial pitting is considered normal and no remedial action is required. Where necessary, initial pitting can be reduced by special tooth finishing means and sometime by a careful break-in at reduced loads and speeds. In some special critical applications, teeth are copper or silver plated to prevent or reduce initial pitting.

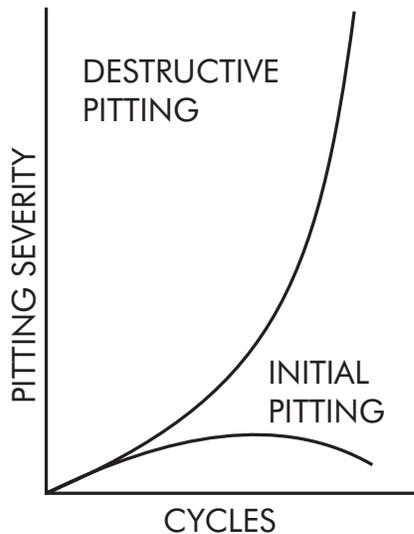
FIG. 2.6 (2342-1C) PITTING SEVERITY

DESTRUCTIVE OR PROGRESSIVE PITTING on the other hand usually starts below the pitch line, in the dedendum portion of the tooth and progressively increases in both the size and number of pits until the surface is destroyed. Destructive pitting can appear to be as severe as corrective pitting at the beginning of operation, however, as time goes on the severity of destructive pitting sharply increases and far surpasses the severity of corrective pitting as shown in **Figure 2.6**. **Figure 2.7** illustrates this type pitting on a through-hardened gear. **Figure 2.8** shows destructive pitting of a surface hardened gear.

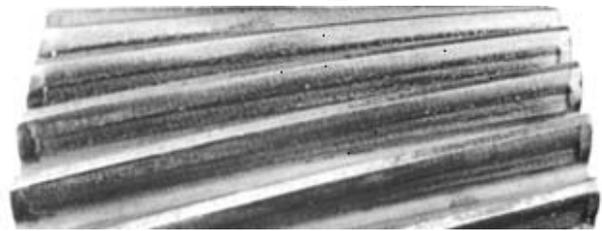
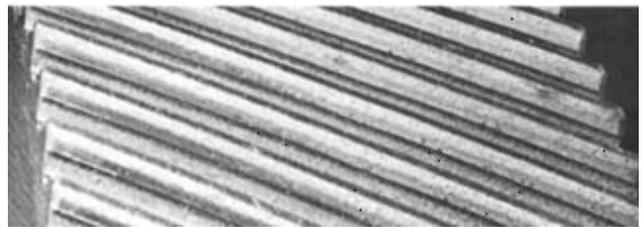
FIG. 2.23 (697-10) TYPICAL TOOTH SURFACE APPEARANCE

Figure 2.23 illustrate wear observed on gears early in their operational history. Subsequently, these gears continued in operation to give years of additional satisfactory service.

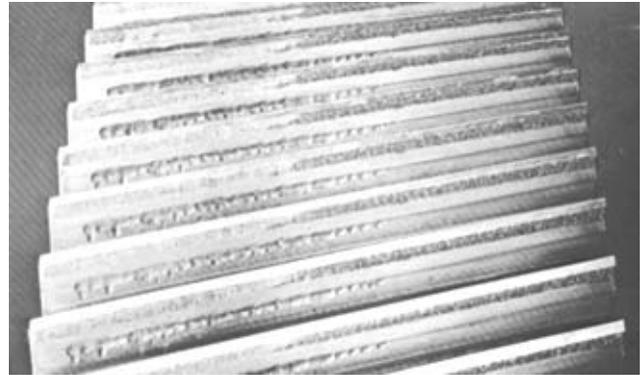
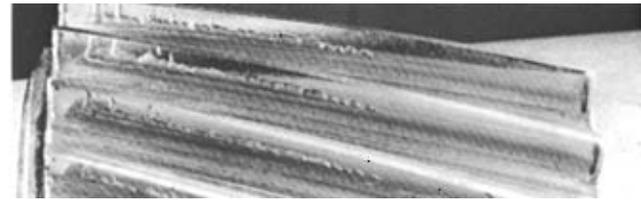
FIG. 2.31 (683-13) WELDING (METAL TRANSFER GEAR TO PINION)

WELDING is a hybrid form of scoring and pitting, where pit cracks are formed on the gear member with pit bodies subsequently adhering or welding to the pinion member. The two then run together with the profile formed by the original involute and the resultant pits bodies and pit cavities, see **Figure 2.31**. This phenomena is thought to occur at high load low speed and at marginal lubrication condition where high contact temperature prevail, but classical scoring doesn't occur. Increased oil viscosities or EP lubricants may help. Reduced loads will aid. Care must be exercised that axial displacement of the mating pinion and gear does not occur as high localized pressure can result from the mismatching of high and low profile spots which could cause fracture. If gearing is disassembled and reassembled, the tooth surfaces should be dressed to remove proud bumps.

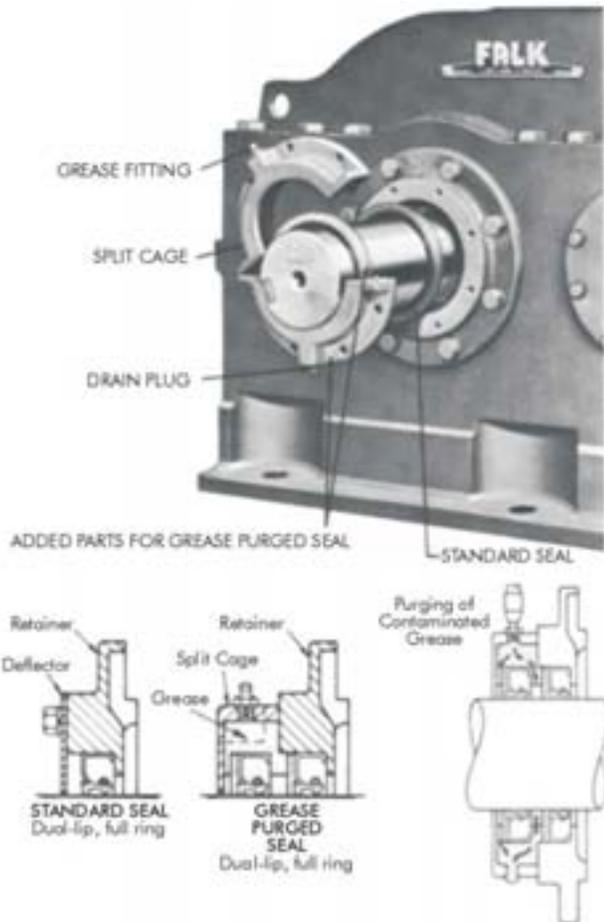
FIG. 5.1 (2342-36C) SEAL ARRANGEMENT

Contact oil seals are used in Falk products as shown in **Figure 5.1**. They are used singularly or in combination with another seal or sealing media such as grease. The oil seal functions by either preventing oil from leaking from an enclosed drive or by preventing the ingress of dirt. The seal consists of a synthetic component bonded to a steel casing. A spring maintains pressure on the lip. The seal will malfunction for one or more of the following reasons, all of which will be explored in this paper.

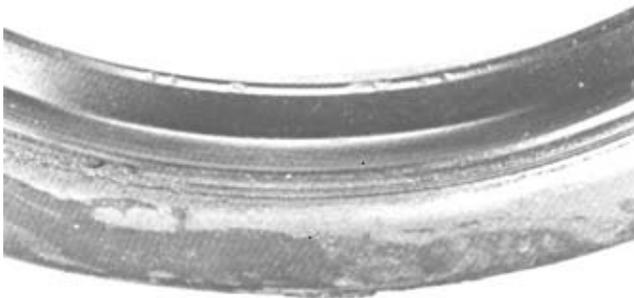
FIG. 5.6 (2342-41C) BLISTERS ON SEAL LIP

HARDENING AND CRACKING OF THE SEAL LIP. Elastomers harden, crack and chip at the lip-shaft interface due to excessive heat, exposure to certain extreme pressure lubricants or exposure to chemicals. The cracking is shown in **Figure 5.4**. Chipping is shown in **Figure 5.5**. Laboratory tests have indicated that a Nitrile seal (most commonly used in a Falk drive) heated to 320° F will harden to the consistency of a phonograph record within 15 minutes. Another failure mode associated with heat is the formation of blisters on the sealing lip as shown in **Figure 5.6**.
