*AUTHOR**G. C. POKRANDT**Project Engineer**Clutch and Coupling Engineering*

The purpose of this paper is to review and identify the types and causes of field failures of the Steelflex coupling. Solutions to prevent failures are proposed.

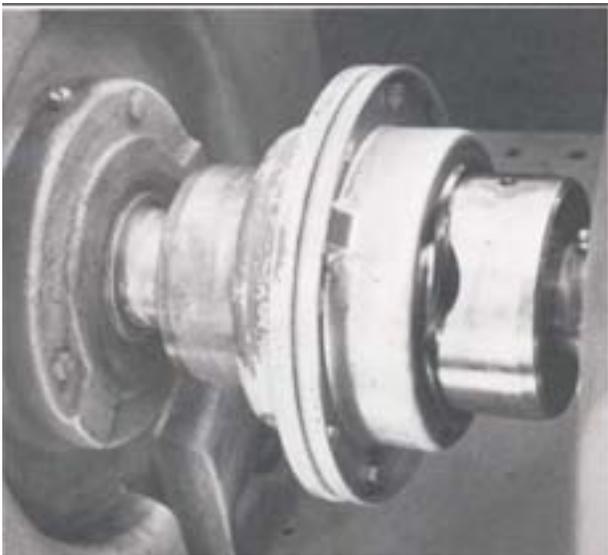
FIGURE 11 (EG-46155)

the seal helps guide the seal into the seal cavity of the cover. Gaskets are used to seal the coupling cover splits on both T10 and T20 styles of couplings. Grease leakage through properly installed gaskets have not been a problem with Steelflex couplings.

Good installation practice is the key to correcting or avoiding gasket leakage problems. The fasteners holding the gasket joint must be properly tightened. Torn or used gaskets should be replaced, and the contacting cover surfaces should be free from burrs and scratches that would either damage the gasket or provide a path for the grease to escape. In a rotating coupling, grease is subjected to a centrifugal force that creates hydraulic pressure on the gasket or seal.
