**Rexnord Solution:**  
Falk Quadrive®  
Shaft-Mounted Reducer

## Quadrive Shaft-Mounted Reducer saves lumber company over \$30,000 per year.

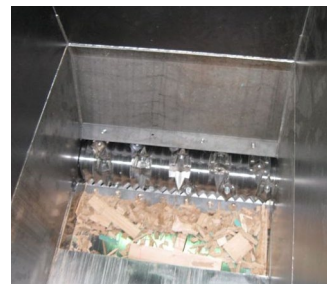
Wood feeds into the chipper, where it is processed into pellets for wooden stoves.
