Application
Cement bucket elevator

Rexnord Solution:
Rexnord® SJM984 Sealed Joint Chain

Sealed Joint Chain Reduces Cement Plant Chain Costs by Half

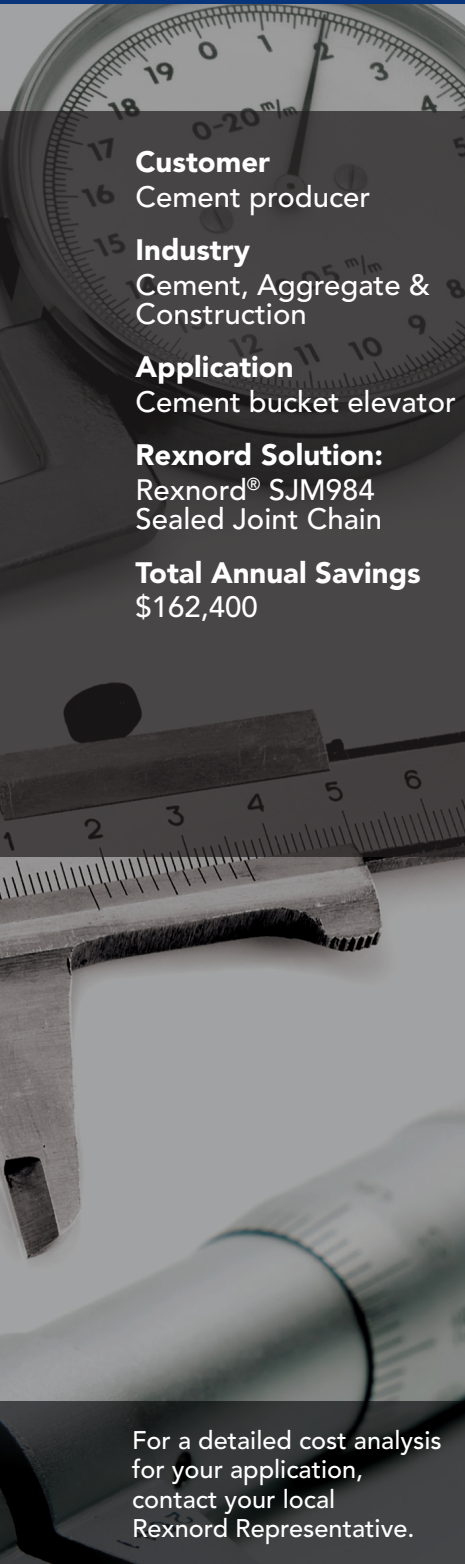
SJM984 Sealed Joint Chain extends wear life in demanding applications.

- **Offers an average of 30 percent more wear life** than a standard chain.
- **Uses pins that are induction-hardened** through a proprietary process that accurately controls the metallurgy of the pin. The resulting hardness features allow for both shock-loading strength and wear resistance in hostile environments.
- **Has a seal feature that acts as an additional shield** to exclude materials from between the pin and bushing gap. Seals are available in both nitrile and Viton®* material for high temperature applications.
