New Bearings Extend Life On Hardwood Producer's Induced Draft Fan

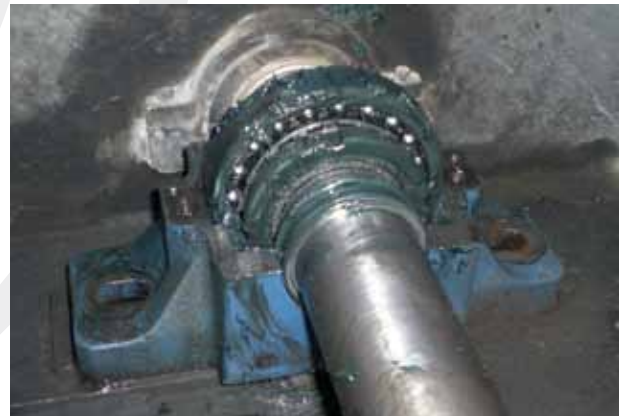
Previous split-block roller bearing design required field assembly that made it difficult to set clearances accurately and allowed contaminants to enter the bearing.

To extend bearing life and reduce installation time, the company replaced them with Rexnord® ZAF6000 series SHURLOK® bearings that are solid-housed, shaft-ready units and are a drop-in replacement for the traditional SAF units. They are greased and the clearance is preset, so they can be taken out of the box and mounted immediately to the shaft, which eliminates contamination and clearance uncertainties. They feature a positive locking system that maintains mounting tightness during operation. The tapered adapter sleeve

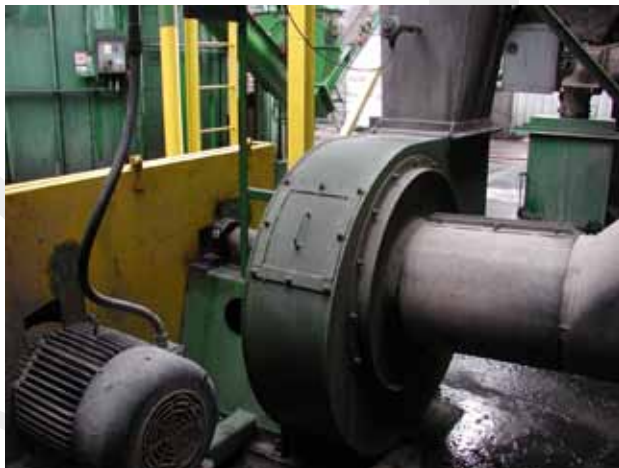
Bearings on this induced draft fan at a major hardwood mill were failing frequently before they were changed to Rexnord ZAF6000 Series SHURLOK® Adapter Mounted Roller Bearings.

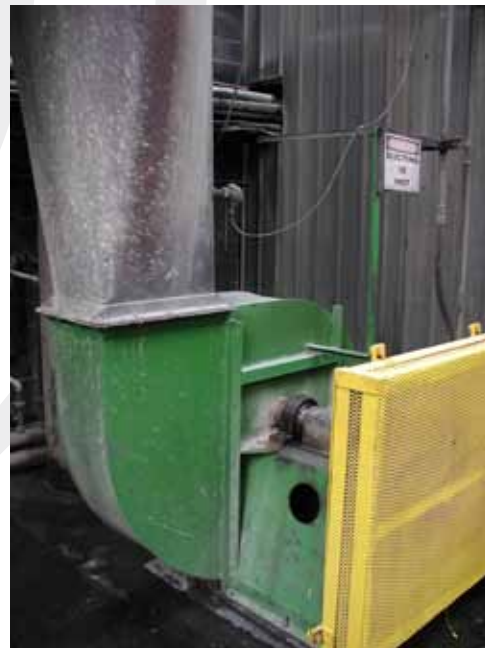
Closeup shows new bearings in place, with induced draft fan housing at right and guard for V-belt speed increaser at left.

Two slightly different types of bearing were used in this application. While a Rexnord ZAF6207 was installed on the drive side, a Rexnord ZAFS6207 was used on the fan side. The latter bearing is a floating unit that allows the cartridge that holds the bearing to slide back and forth in the cast iron pillow block housing. This permits the bearing to accommodate shaft expansion caused by heat that may be present at higher speeds.

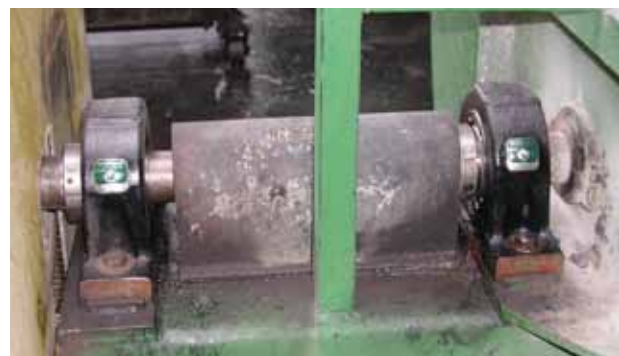
Shaft between V-belt drive and fan is supported by two bearings.
