Location:
Major hardwood mill in the Northwest

Problem:
Bearings were failing in four to six weeks due to environmental conditions and installation method.

Solution:
Old bearings were replaced with Rexnord ZAF6000 Series SHURLOK Bearings.

Rexnord ZAF6000 Series Bearings Dramatically Extend Bearing Life On Hardwood Producer's Induced Draft Fan

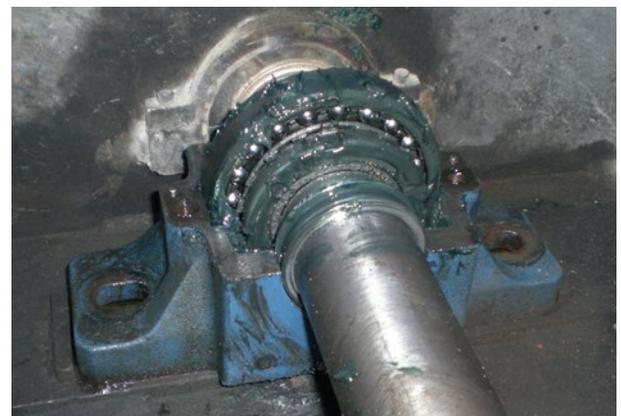
Previous split-block roller bearing design required field assembly that made it difficult to set clearances accurately and allowed contaminants to enter the bearing.

Environmental conditions including heat, dust and an overhung load contributed to the short life of the previous bearings. In addition, their split housing made it necessary to assemble the bearings and set clearances on site. The installation method for the split housed bearings required pre-measuring the clearance and tightening the tapered adapter nut in increments, using feeler gauges to determine when a specified reduction in clearance is reached. If this procedure is performed correctly the shaft grip force will be correct, but it is often performed incorrectly. If the shaft grip is too loose, the bearing may loosen on the shaft. If it is too

tight, the clearance in the bearing is reduced, which can generate excessive heat. In addition, the dust and ash particles in the air made it almost impossible to keep the bearings clean during the assembly and installation procedure.

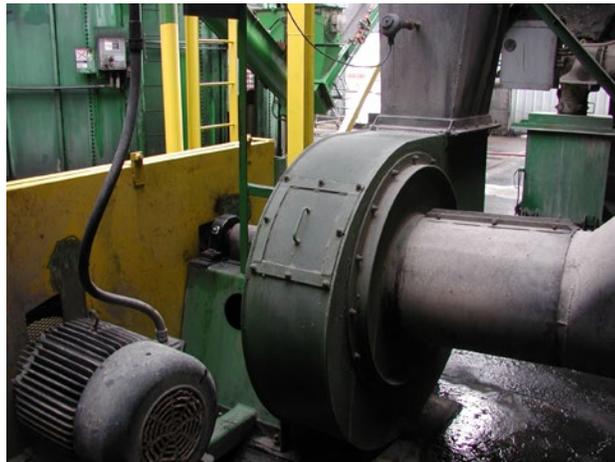
Bearings on this induced draft fan at a major hardwood mill were failing frequently before they were changed to Rexnord ZAF6000 Series SHURLOK Adapter Mounted Roller Bearings.

To extend bearing life and reduce installation time, the company replaced them with Rexnord ZAF6000 Series SHURLOK Bearings that are solid-housed, shaft-ready and are a drop-in replacement for the traditional SAF product. They are greased and the clearance is preset, so they can be taken out of the box and mounted immediately to the shaft, which eliminates contamination and clearance uncertainties. They feature a positive locking system that maintains mounting tightness during operation. The tapered adapter sleeve provides greater shaft grip and eliminates the shaft damage caused by loose bearings. In addition, the tapered sleeve makes it easier to remove the bearings from the shaft without causing damage, saving both time and repair costs. They also eliminate damage to the shaft and bearing caused by improper tightening during bearing installation.

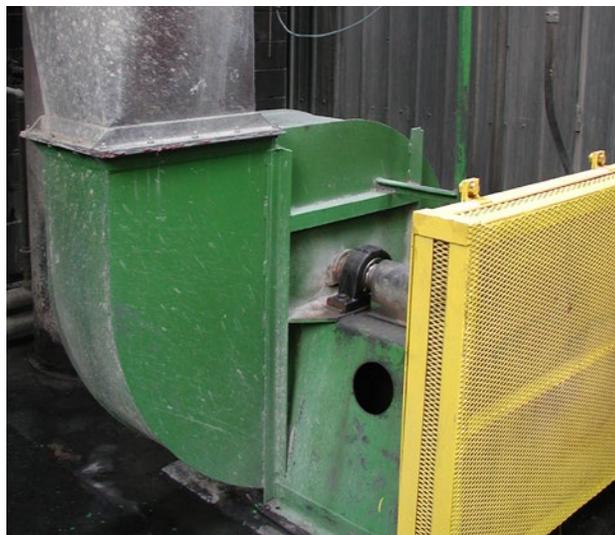
Closeup shows new bearings in place, with induced draft fan housing at right and guard for V-belt speed increaser at left.

Two slightly different types of bearing were used in this application. While a Rexnord ZAF6207 was installed on the drive side, a Rexnord ZAFS6207 was used on the fan side. The latter bearing is a floating unit that allows the cartridge that holds the bearing to slide back and forth in the cast iron pillow block housing. This permits the bearing to accommodate shaft expansion caused by heat that may be present at higher speeds. A company spokesman reports that it generally took at least three to four hours to replace the previous bearings. Typically, the new bearings can be installed in seven to ten minutes each.

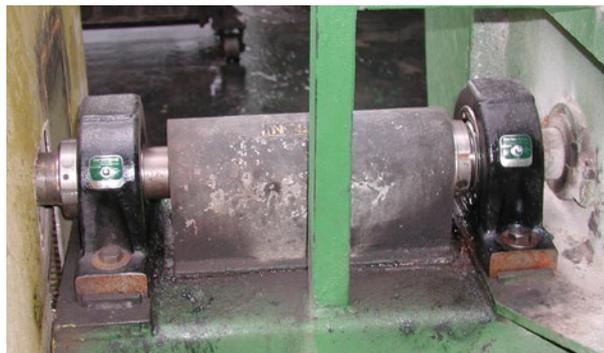
Shaft between V-belt drive and fan is supported by two bearings.
